Dunstable Town Council
Grove House
76 High Street North
Dunstable
Bedfordshire
LU6 1NF

Date: 19 June 2024

A G E N D A

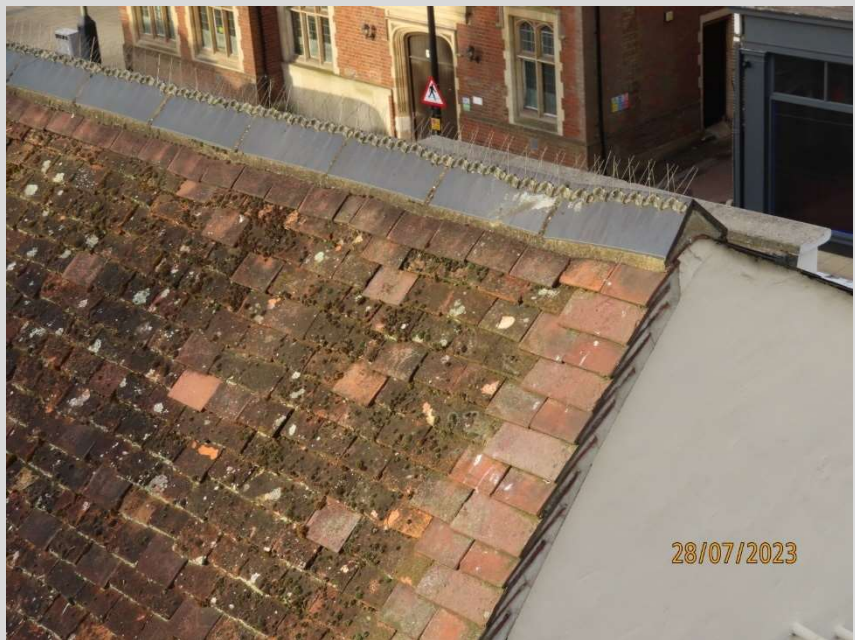
PHOTO 11.2.2a:

- 11.2.2 There have been many isolated repairs of the years with many areas of tiles inserted which are of different colours, ages and composition. This is fairly typical with older roofs.

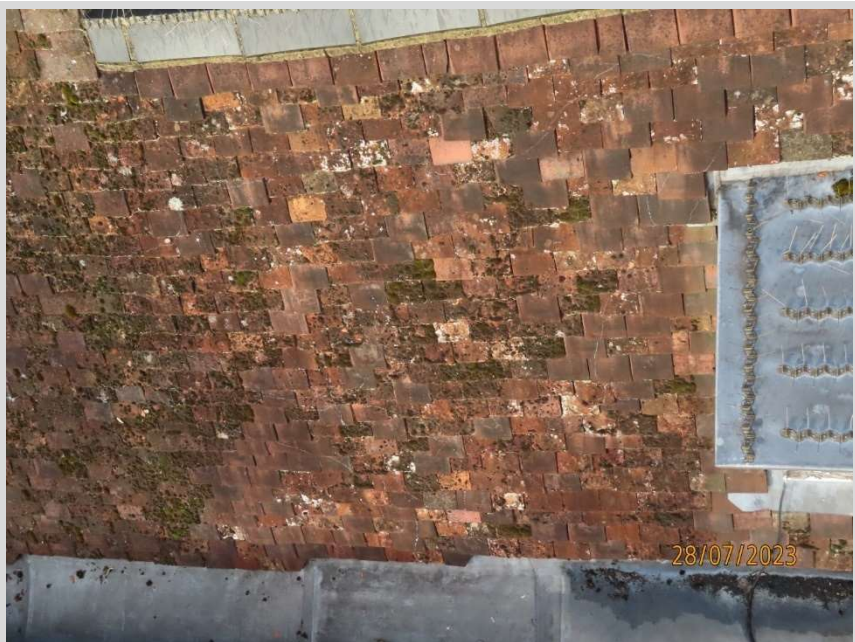
PHOTO 11.2.2b:

Numerous patch repairs to rear slope.

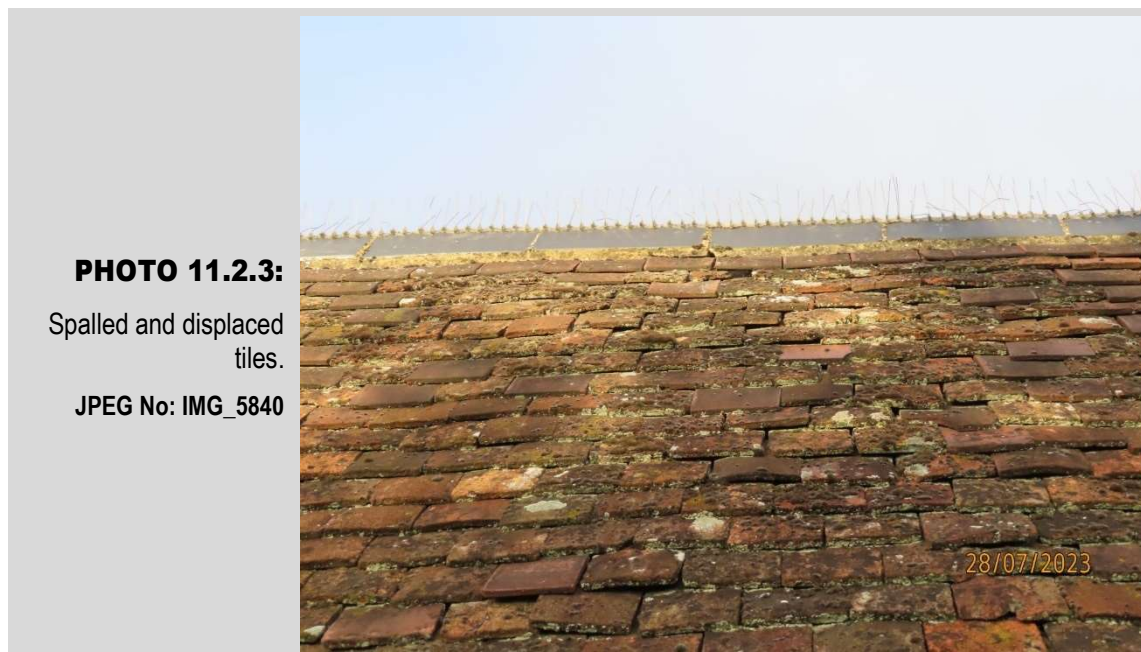
- 11.2.3 Close inspection reveals that many of the older tiles are in a poor state of repair being spalled, cracked or displaced and have possibly lost their fixings to the tile battens behind.

- 11.2.4 Some of the replacement tiles have not been skilfully inserted; these too are either cracked or displaced which, is clearly seen by the uneven and irregular edges across the lower line of the tiles.

- 11.2.5 From this brief description, it can be seen that over the years there have been many isolated tile repairs and replacements, but having reviewed the roof slopes in their entirety we believe that the east facing slopes are now due for comprehensive re-roofing of the tiled surfaces.

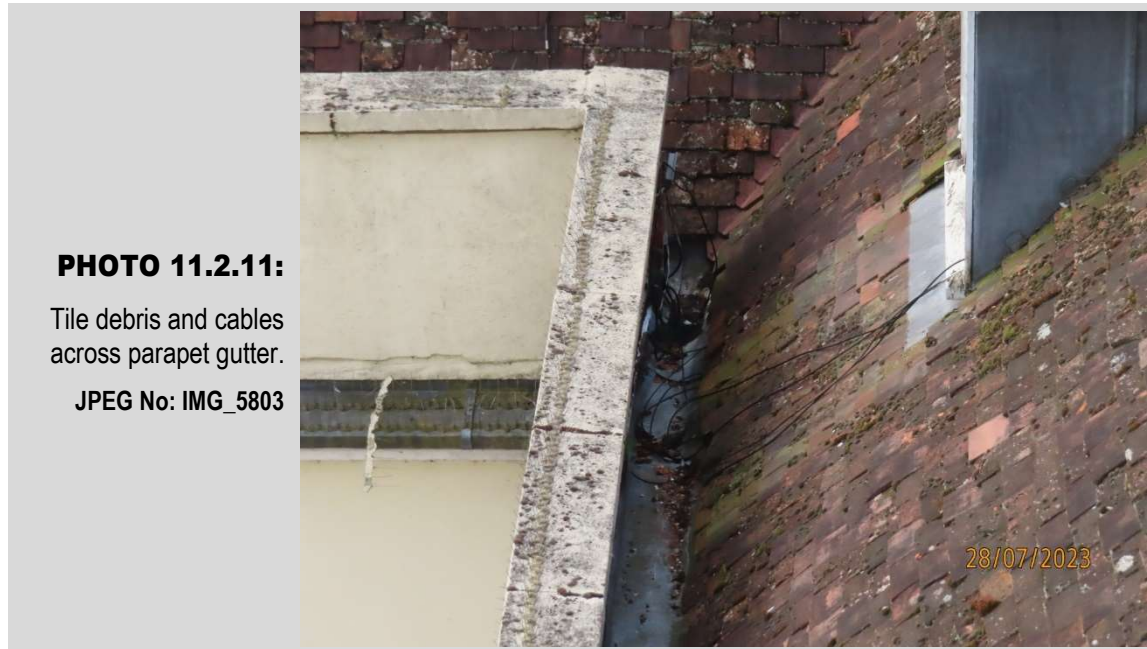
- 11.2.11 There is also tile debris within the parapet gutters, which over time will either cause blockages in the parapet gutters themselves or possibly the hopper heads and downpipes.

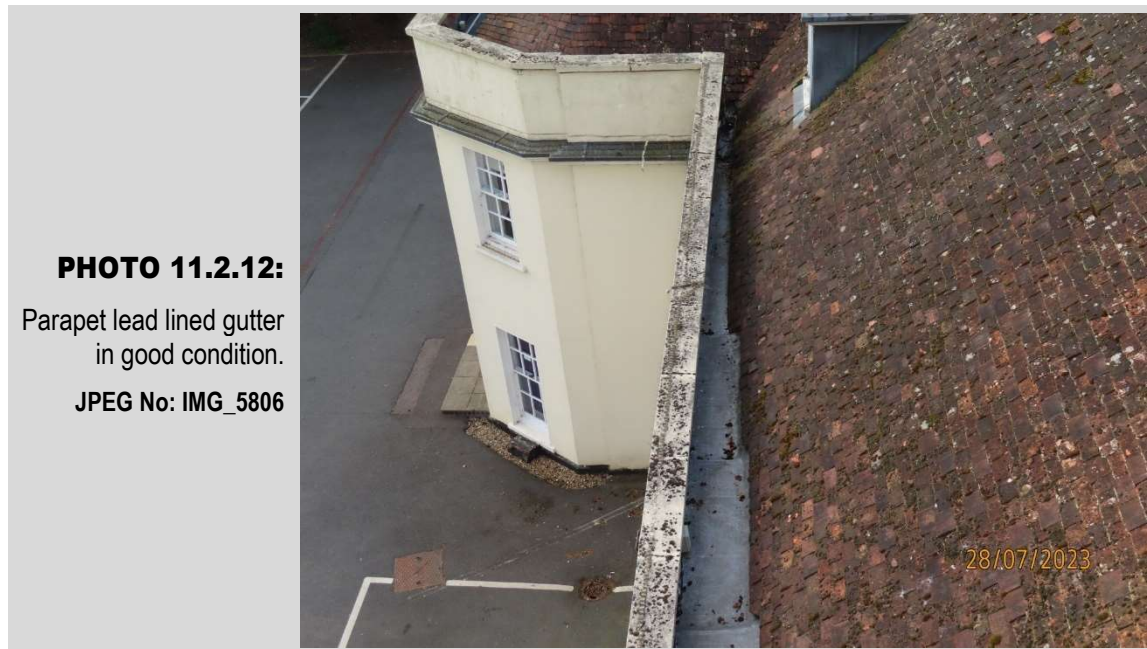
- 11.2.12 On the south side, the lead lined parapet gutters are largely free from blockage with only minor moss debris which is a positive observation. The lead lining itself was inspected and generally noted to be free from defect.

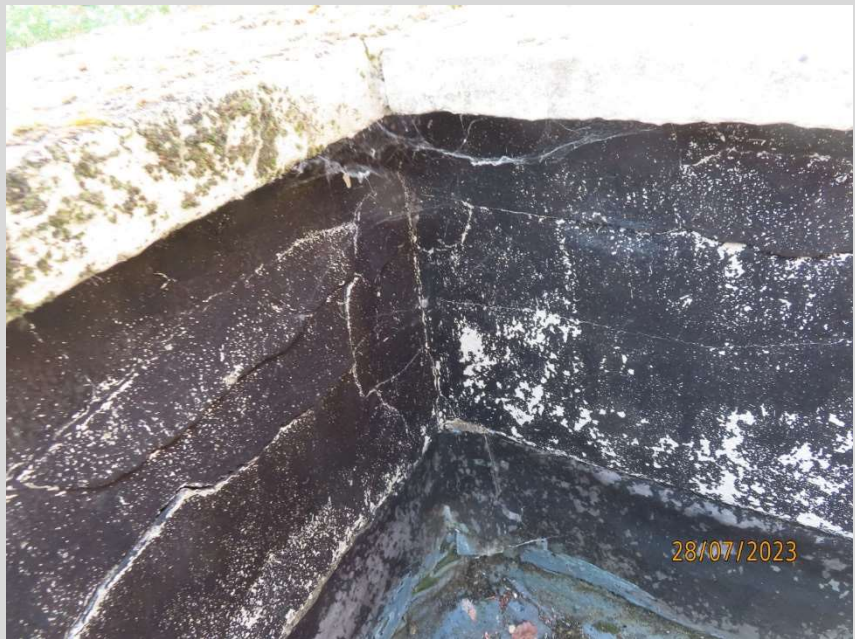
PHOTO 11.2.13a:

- 11.2.13 On the north side and around the bay construction, the parapet wall and gutter is in much worse condition and needs repair. The internal rendering which has been painted black, presumably in an attempt to provide some improved moisture resistance, is crazed and cracked throughout and in some sections, it is completely missing; exposing the brickwork behind which is generally in poor condition.

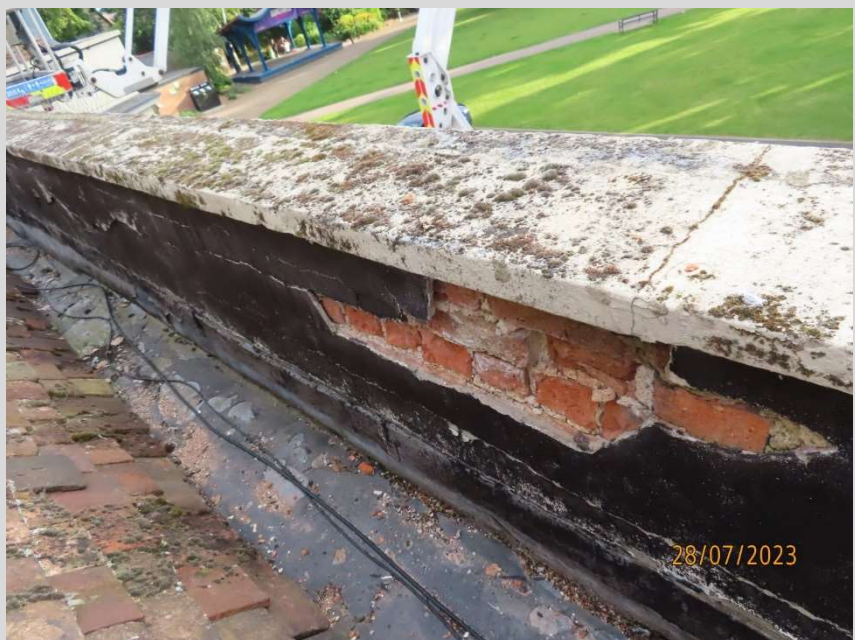
**PHOTO 11.2.13b:**

Missing render to parapet wall with spalled brickwork behind.

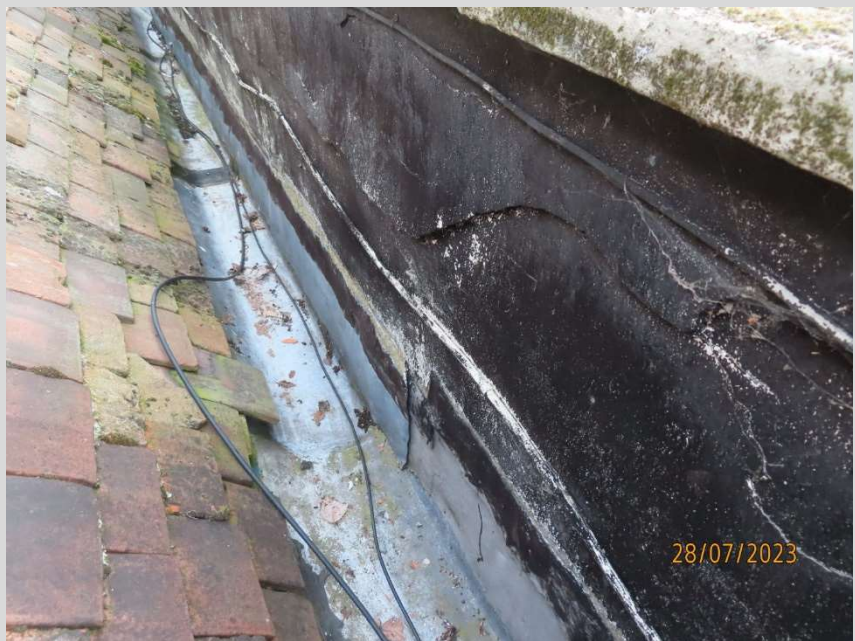
PHOTO 11.2.13c:

Cracked and displaced render to inside face of parapet wall.

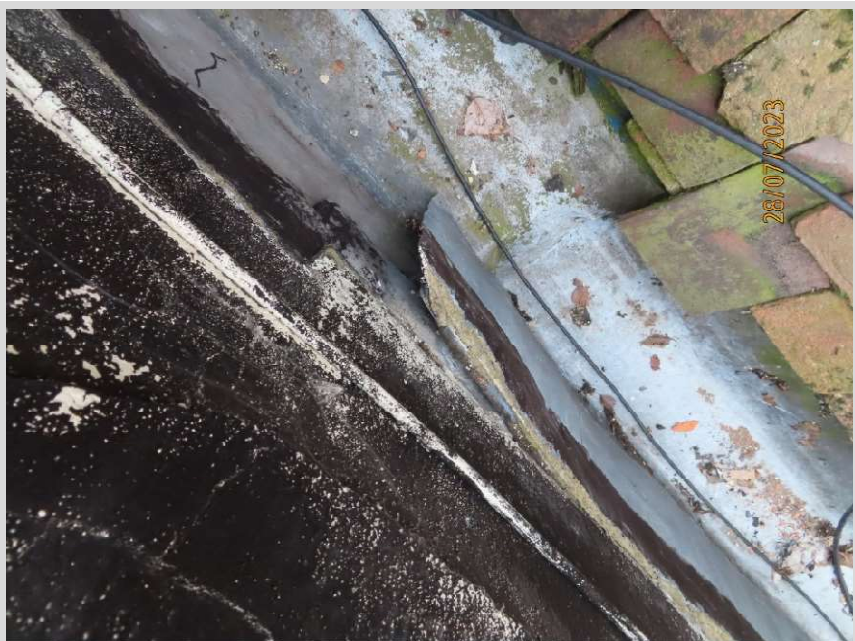
PHOTO 11.2.14a:

- 11.2.14 In many places the gutter lining and flashings are displaced or have been coated in proprietary sealants of various types, which clearly have been an attempt to prevent ongoing water ingress. These types of repairs are rarely successful and make matters worse; ultimately the best solution is to remove the linings and flashings and reinstate them with new materials, installed to higher standards of workmanship, quality using better materials.

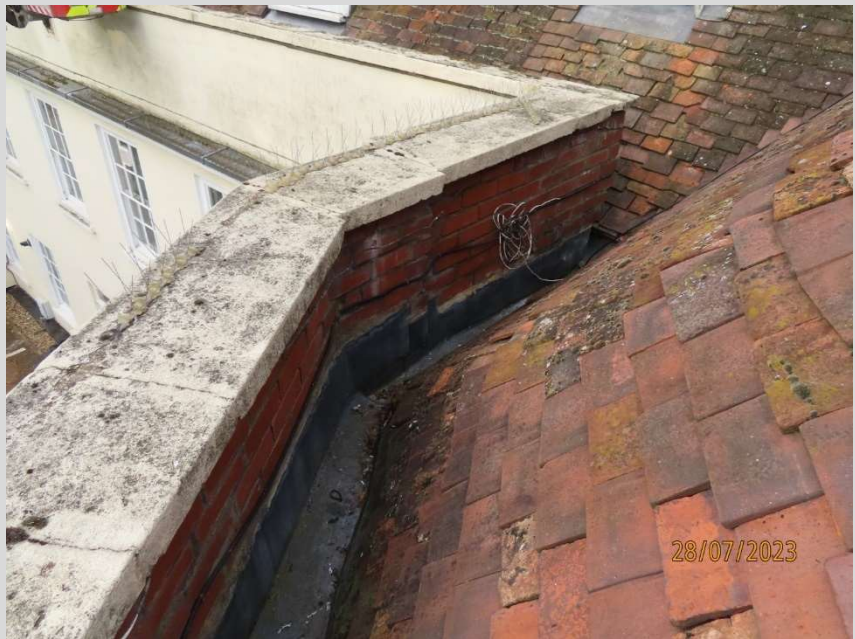
- 11.2.16 In many areas the coping stone joints are heavily eroded, sections are cracked but have been sealed with mastic which, is unlikely to be effective in waterproofing the cracked section, which leads us to conclude that these sections of coping stones should be replaced.

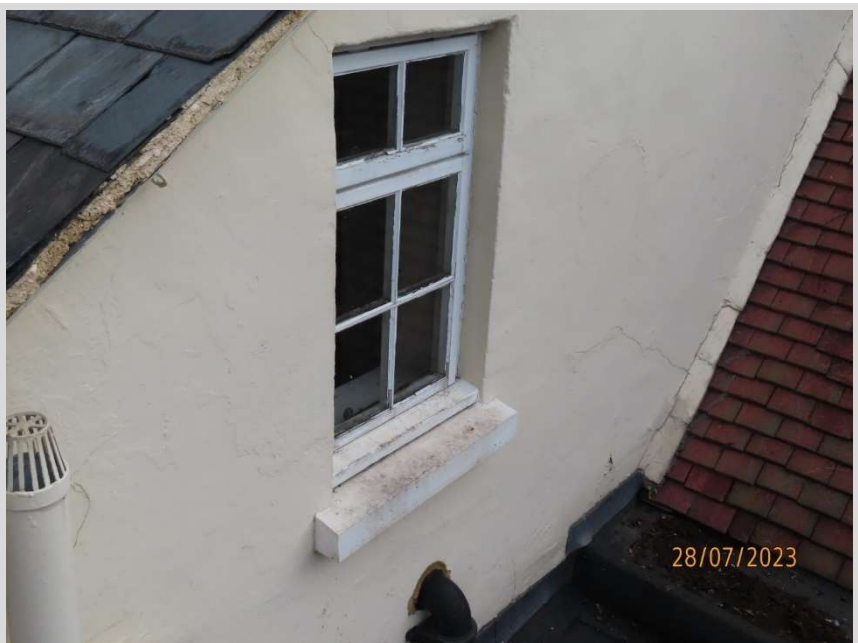
- 11.2.21 The main defect with this roof at the present time is the defective cement mortar pointing on the verges (edges) of the slates where they overhang the gable walls below. The mortar pointing should be renewed to prevent displacement of the slates and possible water ingress at these vulnerable points.

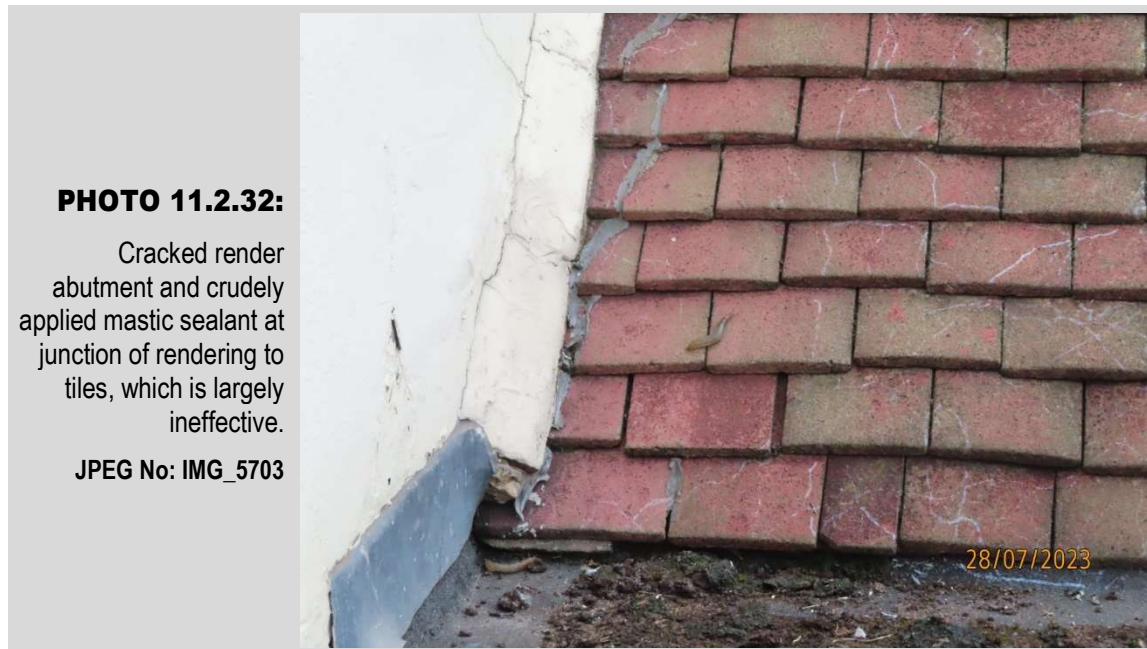
- 11.2.31 This is one of the principal roofs but is set at a lower height than the previously described west roof. It is finished with clay and concrete plain tiling and is generally evenly pitched and consistently aligned. This again indicates that the roof frame stable and not overloaded.
- 11.2.32 On the left hand side of the roof, as viewed from the front elevation, the tiles abut the rendered gable wall so that all roof and wall abutment flashing is beginning to show signs of disrepair. There is a rendered and painted angle fillet which is cracked, and therefore, will be allowing localised water entry. Adjacent to that, a crude mastic sealant has been applied at the junction with the tiles the sealant has also been applied to cracked tiles in an attempt to seal gaps and defects in this junction. This repair is largely ineffective and needs attention.

- 11.2.33 On the right hand side of the roof, there is a lead flashing at the junction with the chimney stack abutment which has been finished with a plastic termination bar screw fixed to the render, and again, sealed with mastic. This is becoming displaced and over time water will penetrate past the termination bar and into the roof slopes below. Over time the timbers adjacent will deteriorate and become decayed, but the decay will not be visible for many years, as it will be hidden from view. It is difficult to seal lead flashings to rendered walls, but they should be cut and chased into the rendering and finished with a bell mouth drip. Over time the screw fixings will also become an issue, enabling water to penetrate into the render.

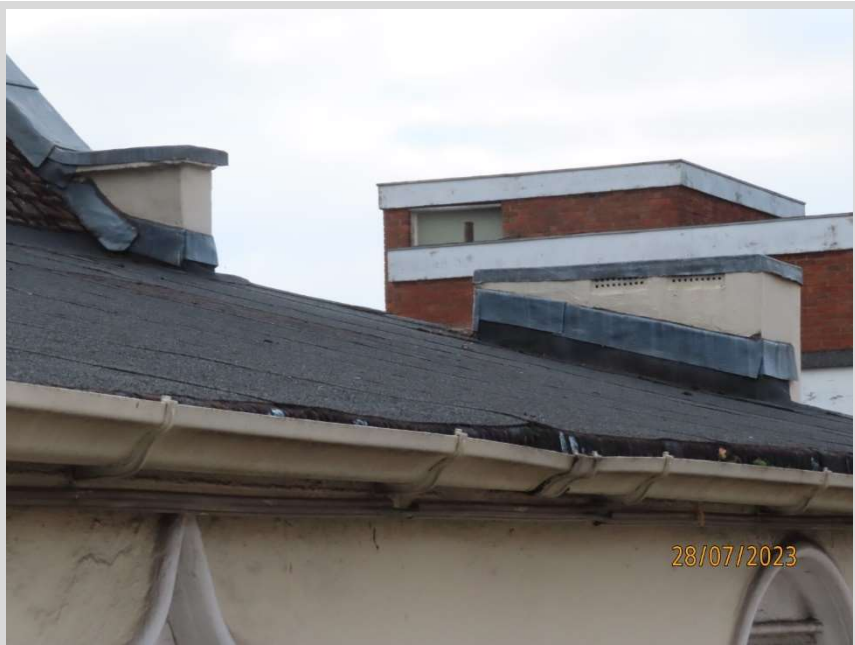
- 11.2.39 The uPVC gutters serving this felt roof are heavily blocked with silt and require cleaning through; we recommend that this should be done every 6 months. The gutter joints are also displaced and require realignment.

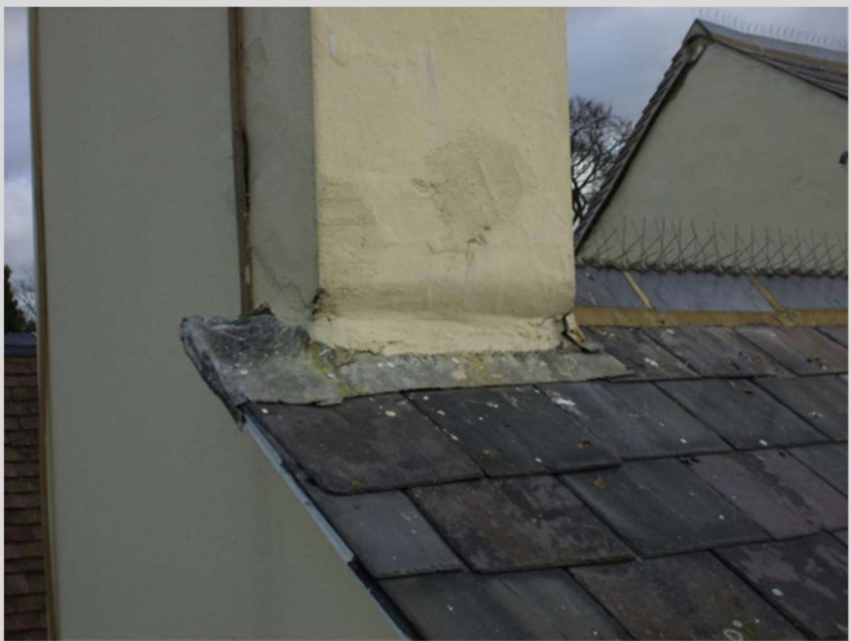
Poor flashings to left hand stack allowing water penetration into roof void.

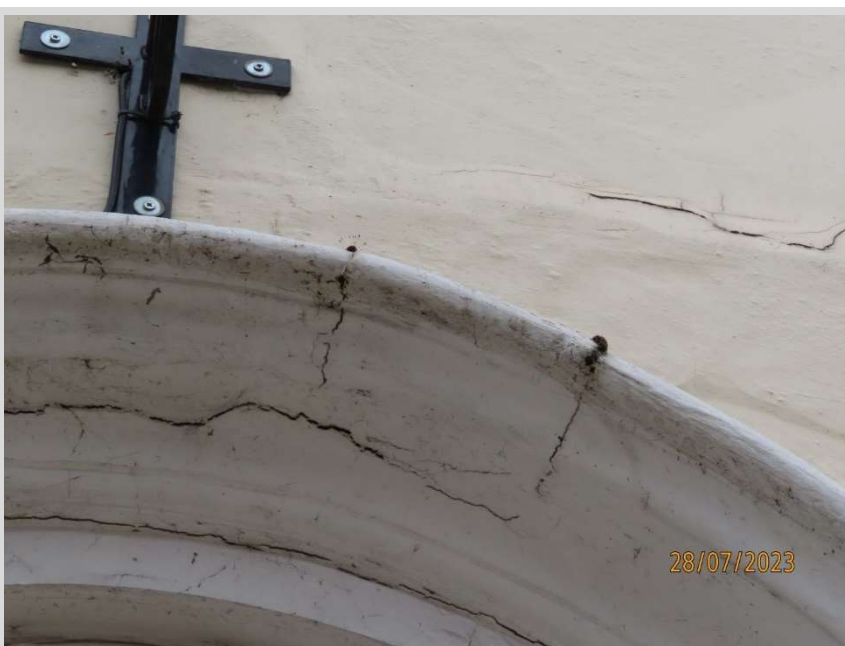
- 15.2.3 The curved sections to the window arches also need repair, as these are cracked and displaced; the render above them appears to be absorbing water which is deteriorating the framing of the curved windows.

- 15.2.4 The doors and door frames also need redecoration, and the timber thresholds and stone thresholds require repair.
- 15.2.5 From this brief description, it could be seen that timber joinery overhaul and repair is necessary to all external joinery items.
