Dunstable Town Council
Grove House
76 High Street North
Dunstable
Bedfordshire
LU6 1NF

Date: 19 June 2024

A G E N D A

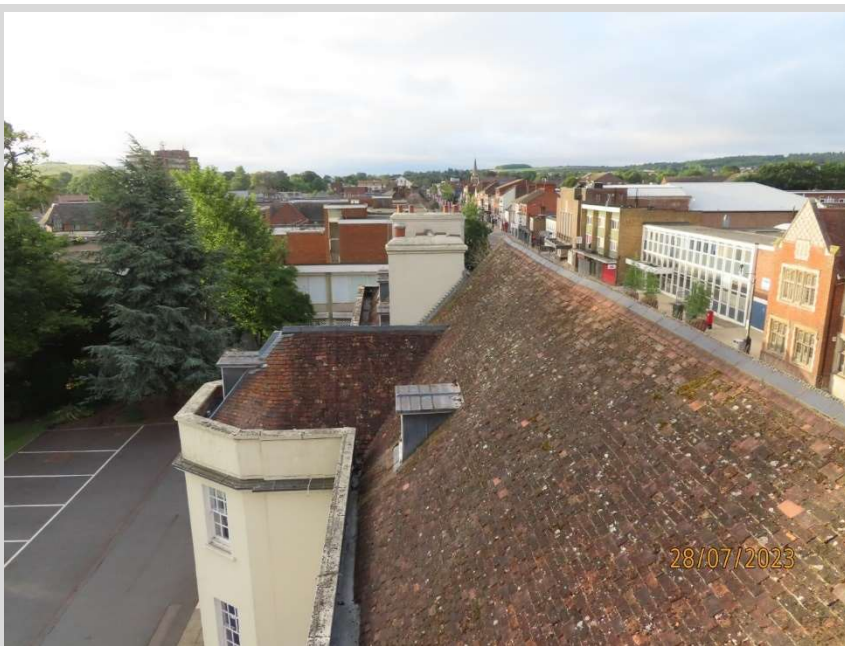
JPEG No: IMG_5797

Rear (east) roof slopes.

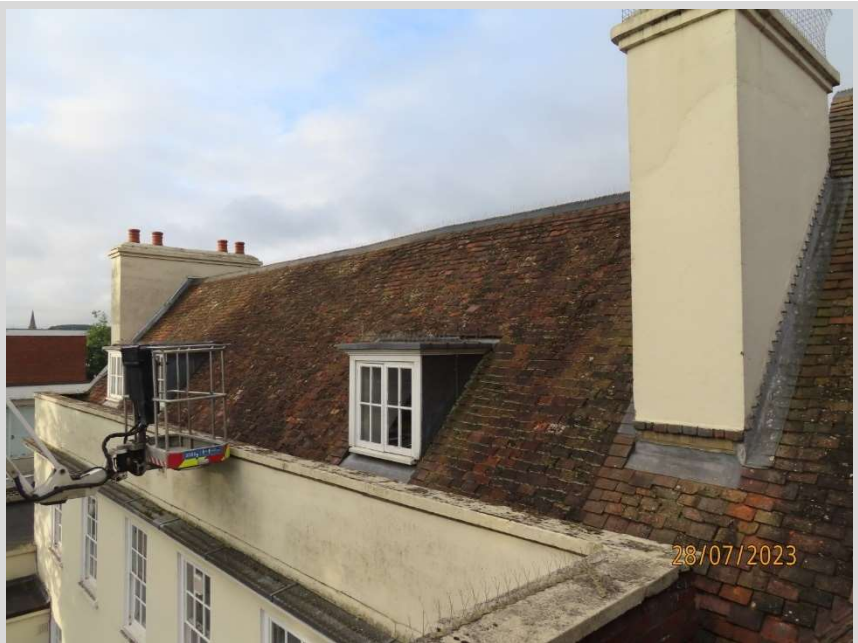
PHOTO 11.2b:

Rear (east) roof slopes.

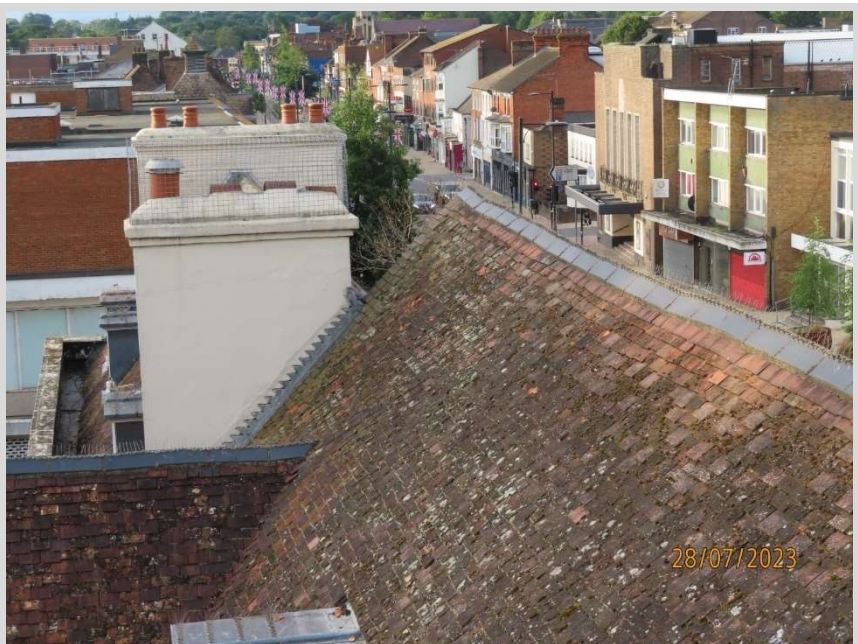
PHOTO 11.2.1:

- 11.2.1 These roof slopes are broadly evenly pitched despite the variety and discontinuity with the roof tiles. The ridge line undulates and is not consistently aligned which indicates that the ridge timbers have moved, sagged or become displaced where they are joined.

Displaced ridge line.

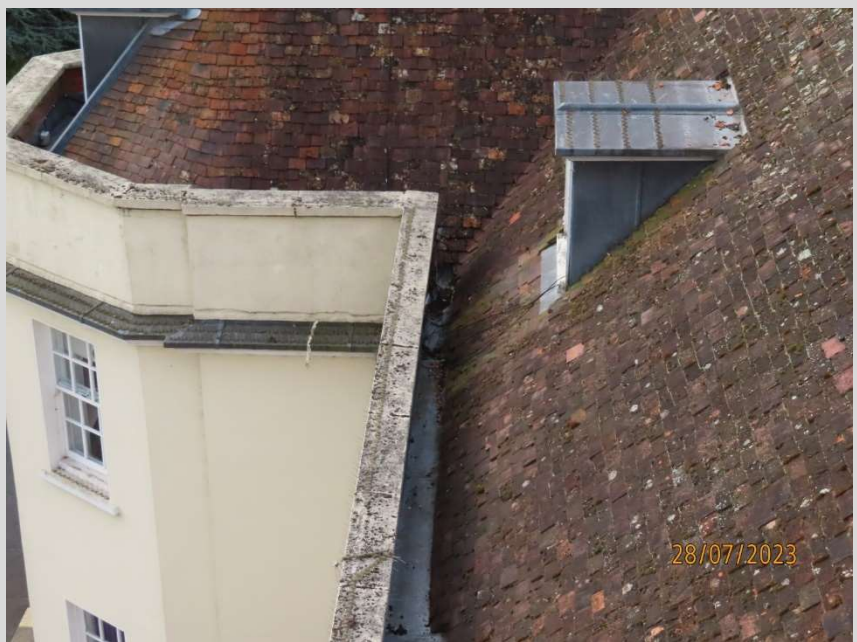
JPEG No: IMG_5798

Parapet copings which require repointing on the joints and redecorating.

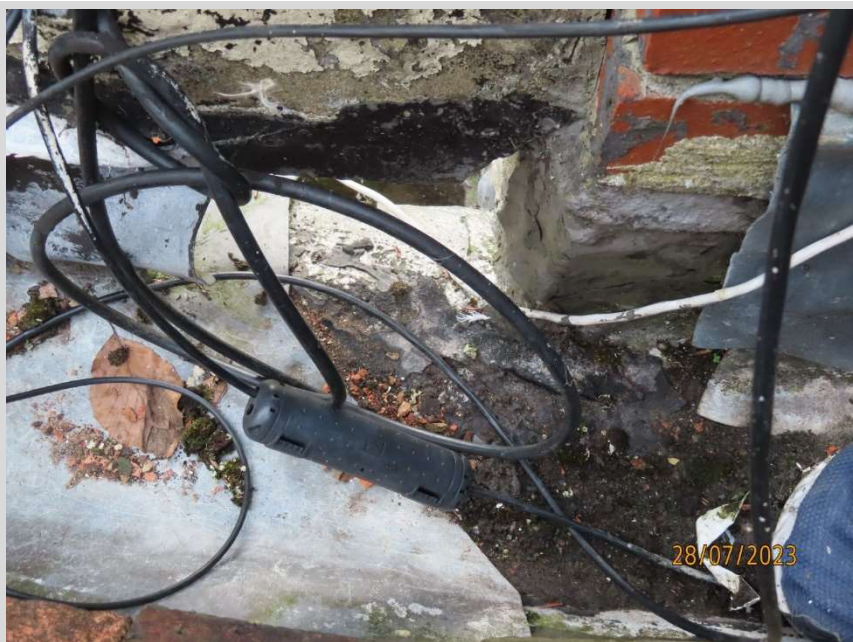
**PHOTO 11.2.14c:**

Mastic sealant repairs to lead lined upstands in an attempt to rectify water ingress adjacent to loose laid cables and accumulated silt and debris. Note: crude mastic sealant applied to seal the lead upstand in brickwork on the right hand side of the photograph.

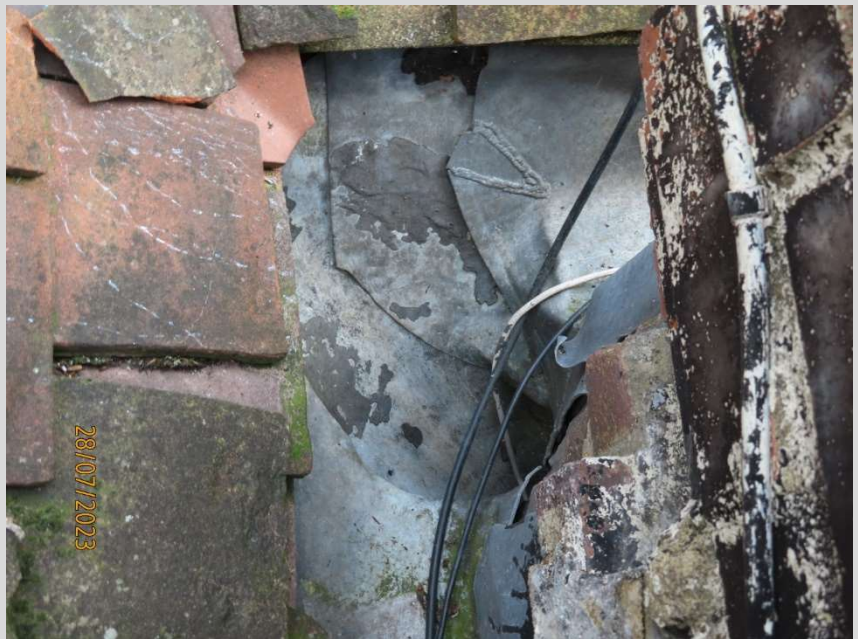
PHOTO 11.2.15a:

- 11.2.15 On the north side of the bay construction, the parapet wall has been reconstructed in modern brickwork but in this location the width of the parapet gutter is too narrow; and probably inadequately drains the rainwater away particularly in storm water conditions. The hopper head outlet in the corner of the junction between the bay and the main rear slope of the north roof is also quite narrow and the parapet wall has been cantilevered over the gutter with a void below. This is a very unusual form of construction and may over time give rise to further water penetration problems. This appears to be an historic configuration, but it is far from ideal. Any changes to the configuration will need Listed Building Consent, which may be problematic but in the short term, repair and overhaul of the gutter lining and junctions of the hopper head and associated flashings and weatherproofing elements is necessary.

Cantilevered parapet wall (black painted bricks) above lead lined rainwater outlet to external hopper head with restricted drainage capacity.

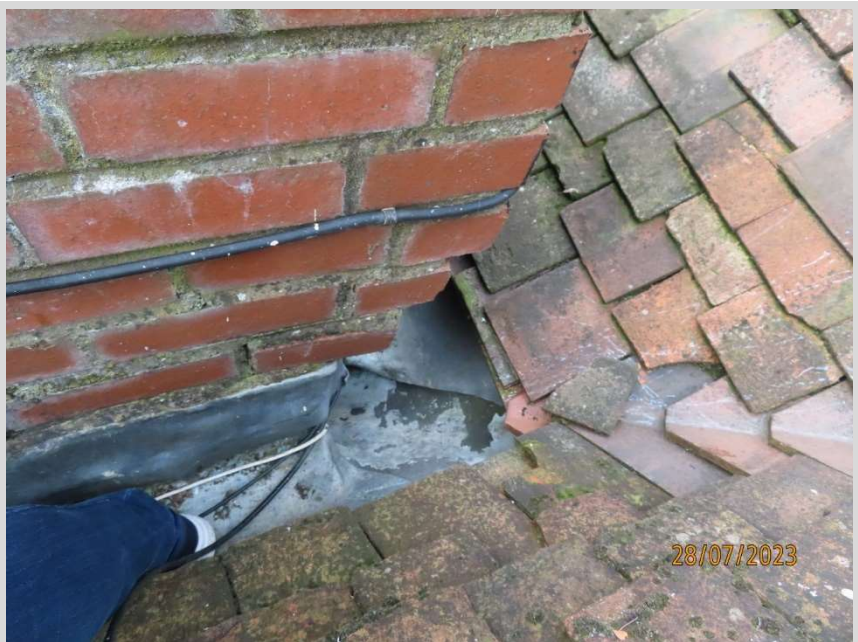
PHOTO 11.2.15b:

Cantilevered parapet wall above lead lined rainwater outlet to external hopper head with restricted drainage capacity.

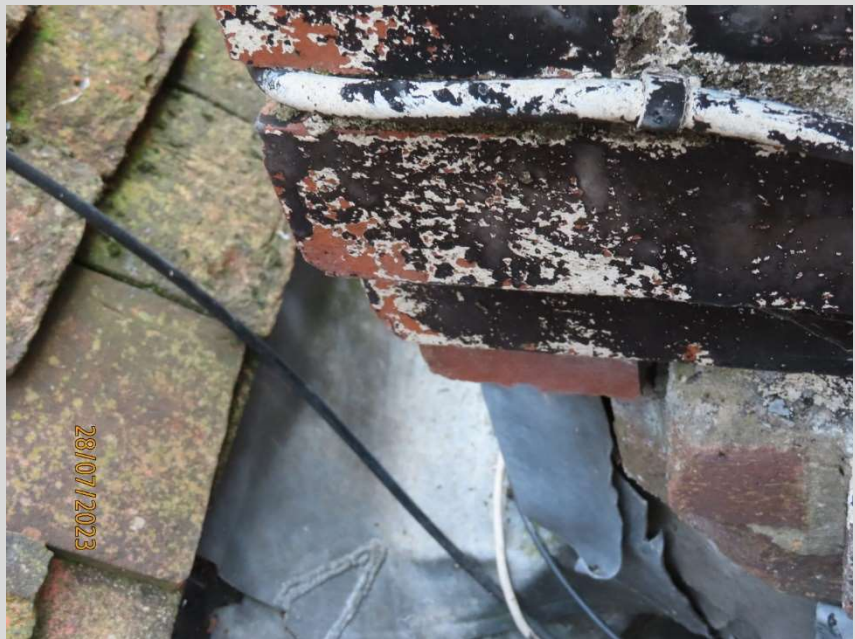
PHOTO 11.2.15c:

Cantilevered parapet wall (black painted bricks) above lead lined rainwater outlet to external hopper head with restricted drainage capacity.

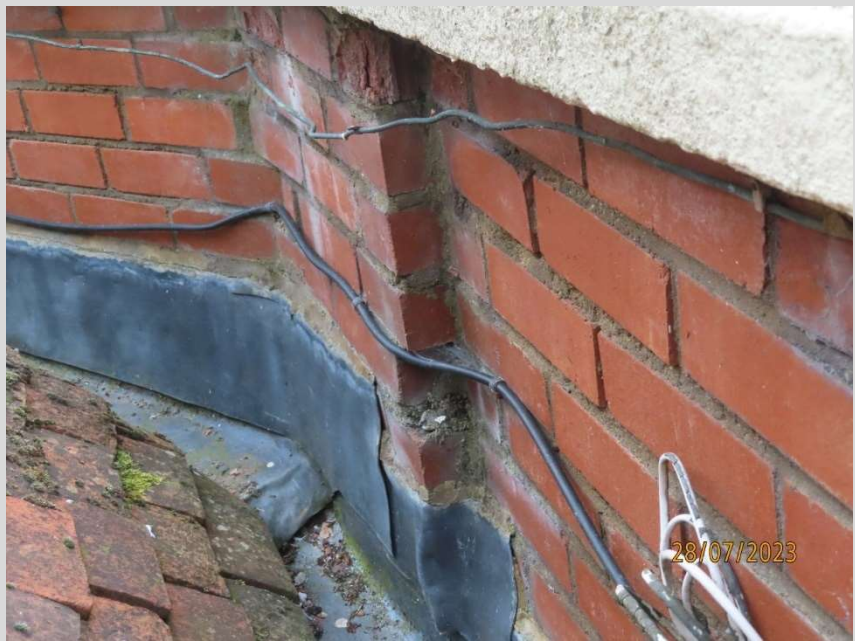
PHOTO 11.2.15d:

Reconstructed parapet wall around bay construction using modern bricks.

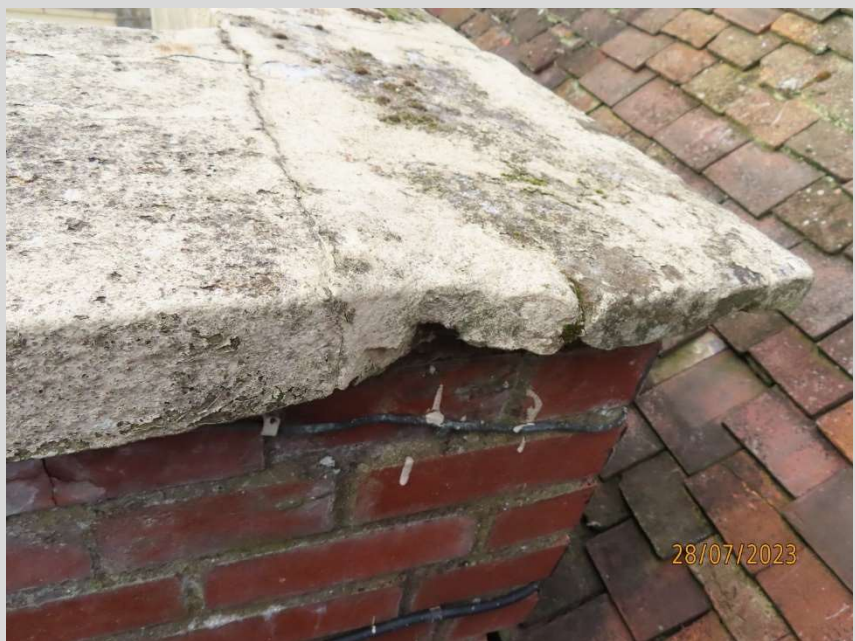
JPEG No: IMG_5870

Cracked and eroded coping stones which require replacement.

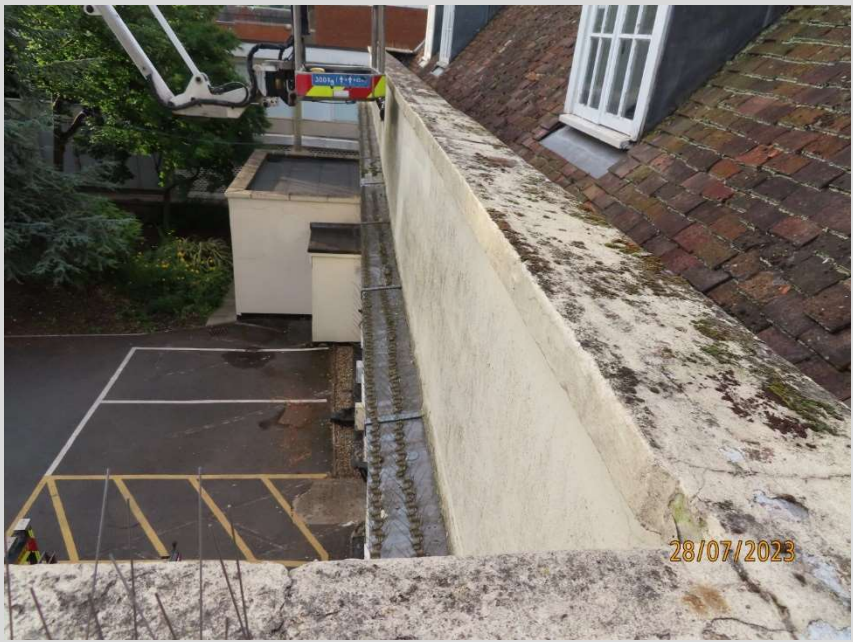
PHOTO 11.2.16b:

Eroded coping stones to parapet on north side of rear elevation which shows that, as a minimum, removal of moss, repointing joints and decoration is required.

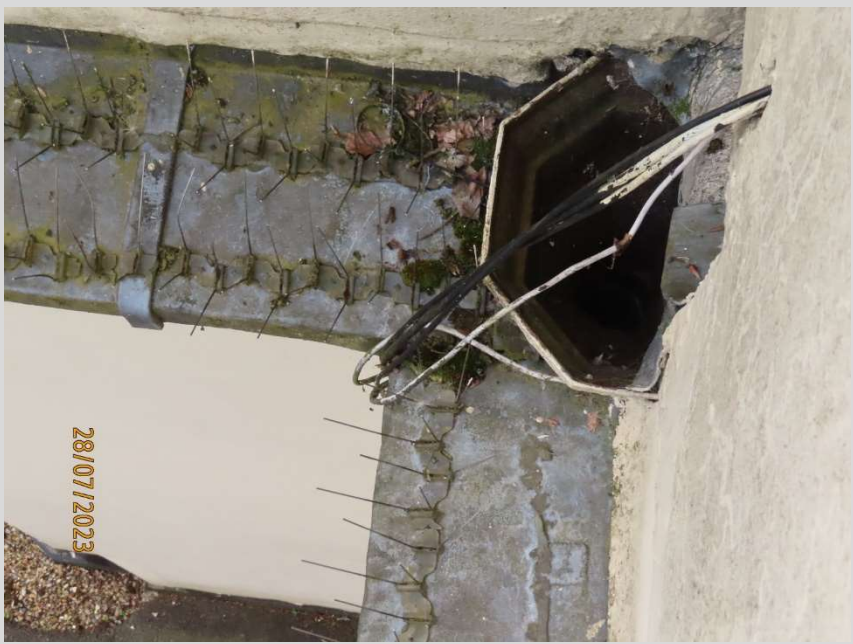
PHOTO 11.2.17:

11.2.17 The lead linings through the parapet walls forming the chutes to the hopper heads all require re-dressing and repair, as the lead work has become displaced.

Displaced lead lining through parapet wall aperture.

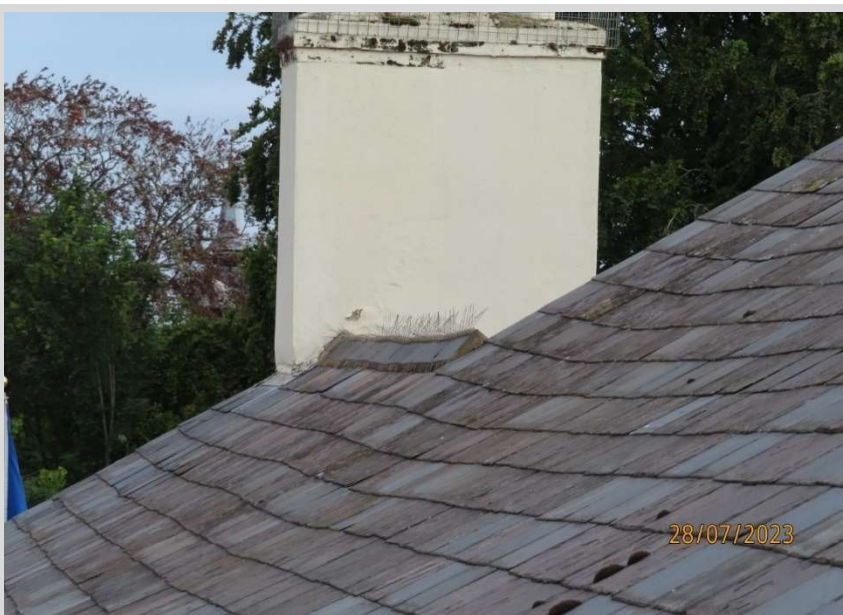
JPEG No: IMG_5717

- 11.2.18 This area is one of the main roof coverings over the tallest part of the property. It is covered with natural slates and terminates into a lead lined parapet gutter behind a raised masonry rendered parapet wall facing the front elevation.
- 11.2.19 The main roof slope undulates slightly, indicating that the timber framework has settled over the years and no longer remains evenly pitched. This is quite evident on the left hand side adjacent to the gable wall and is caused because the gable wall is rigid and has not move much over the years in contrast to the ageing and sagging of the adjacent roof frame.

Gentle sagging of main pitched slate coverings of the front elevation.

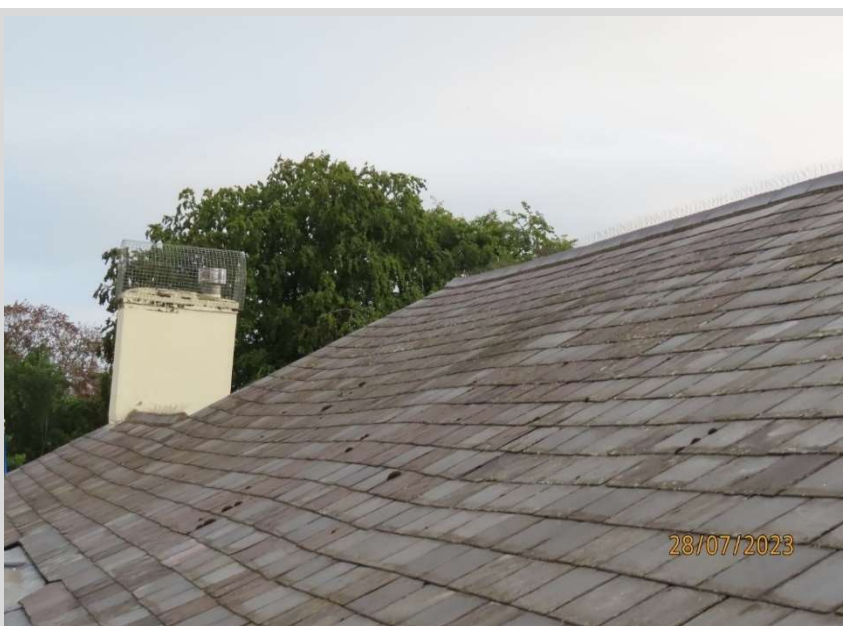
PHOTO 11.2.20a:

- 11.2.20 The slate coverings, although aged, are generally in fair condition and provide a consistent weathering envelope over the roof frame.

Slate coverings over west facing main roof which are generally in fair condition.

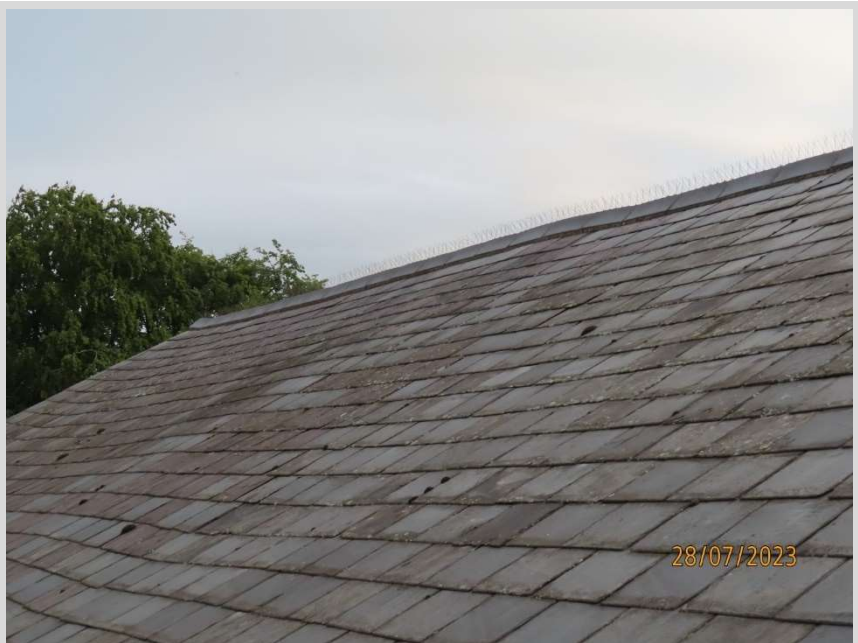
PHOTO 11.2.20b:

Slate coverings over west facing main roof which are generally in fair condition.

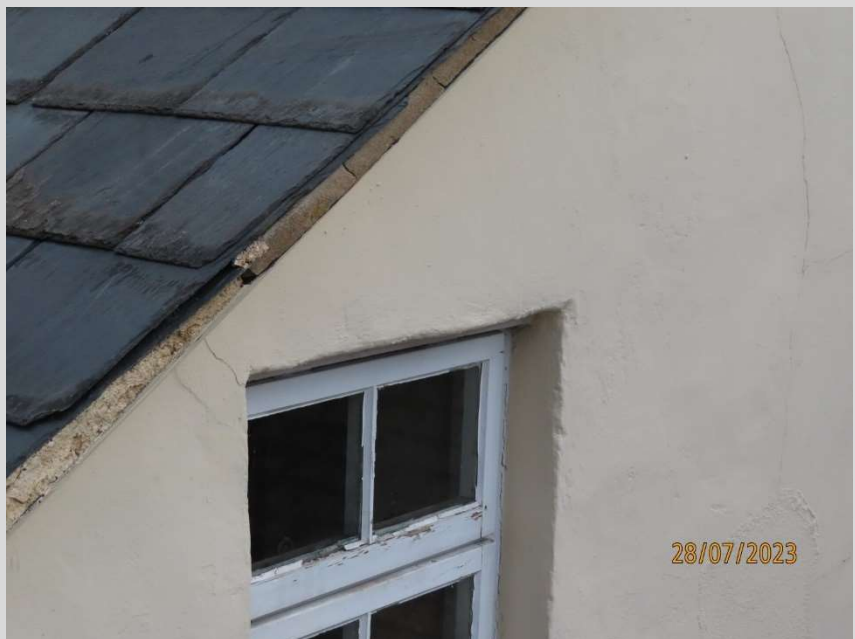
JPEG No: IMG_5738

- 11.2.21 The main defect with this roof at the present time is the defective cement mortar pointing on the verges (edges) of the slates where they overhang the gable walls below. The mortar pointing should be renewed to prevent displacement of the slates and possible water ingress at these vulnerable points.

Defective cement mortar pointing under slates.

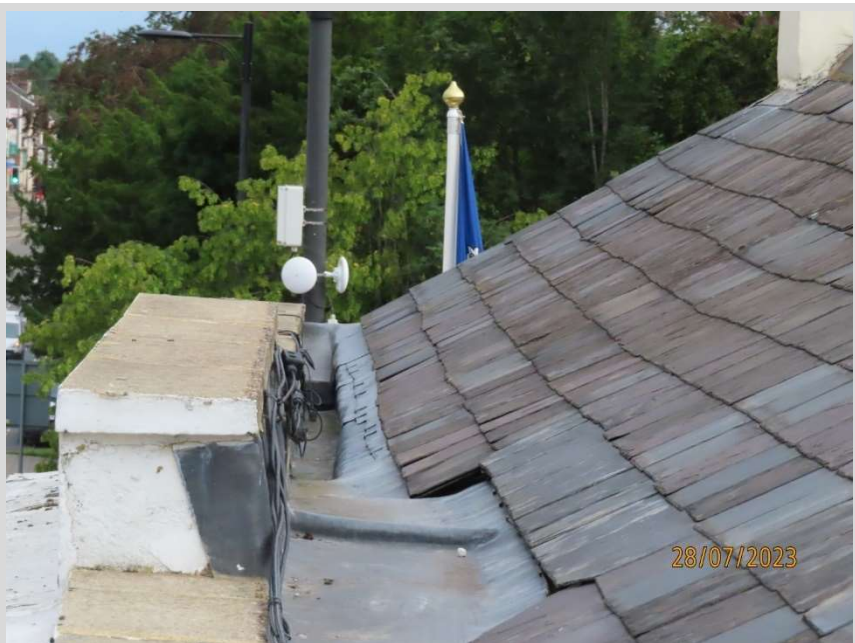
PHOTO 11.2.22:

11.2.22 The leadwork forming the gutter behind the main parapet wall is generally in fair condition; at the time of inspection, no significant defects were noted.

Lead linings to parapet gutters on the west side, generally in fair condition.

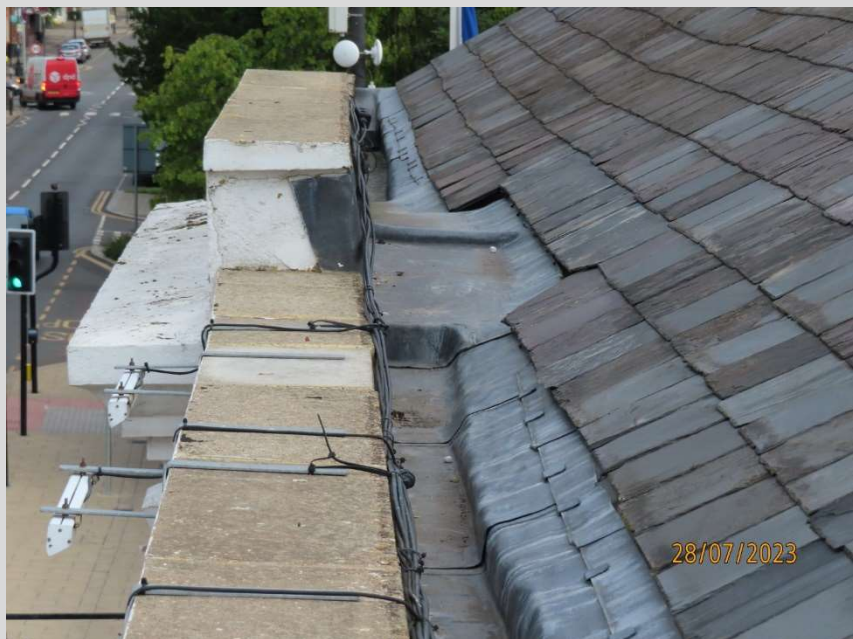
PHOTO 11.2.23:

11.2.23 The copings to the parapet wall are also in fair condition, although they do not appear to overhang the wall below by very much, and therefore, the rainwater run-off from the coping may be compromised and allow water absorption into the masonry below. One section of wall coating appears to have been replaced with a non-matching coping stone. It was also noted that brackets have been fixed through the copings to form supports to the overhead lighting illuminating the elevations, we did not check the fixings of the brackets that they appear to be secure at the time of inspection.

Front parapet wall (west facing) with non-matching coping stone bedded in centre section.

- 11.2.24 Inevitably, the fixings through the coping stones will lead to localised water penetration into the copings and over time the fixing holes will enlarge, and the brackets will become less securely fixed. Ideally, they should be checked every 2-3 years or so to make sure they are still securely fixed, and the coping faces are not becoming excessively damaged.

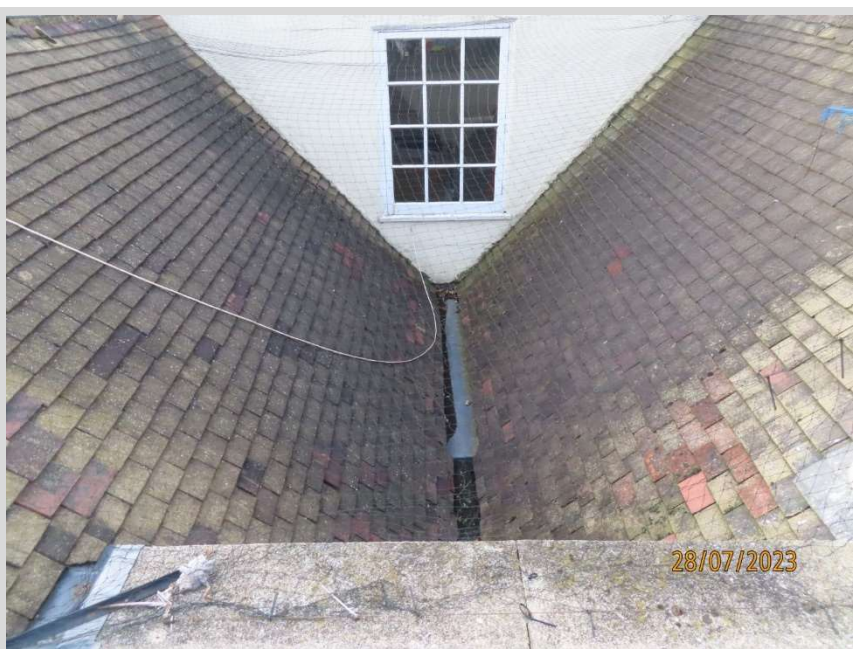
JPEG No: IMG_5762

Inner tiled slopes with lead lined valley gutter between.

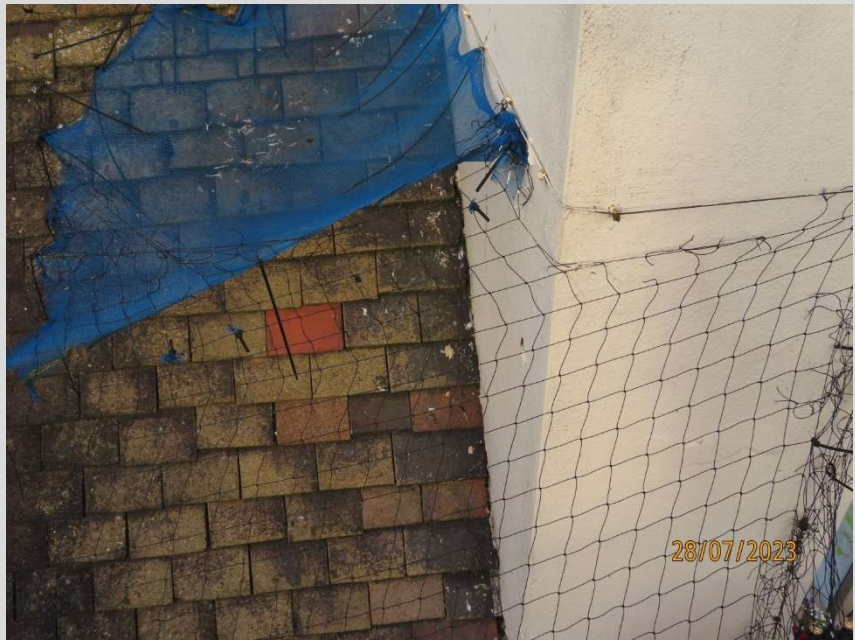
PHOTO 11.2.26:

- 11.2.26 The inner slopes are protected by pigeon netting which is keeping the debris at bay. Part of the pigeon netting has become torn and has been repaired with blue netting as a temporary measure.

Temporary repair using blue netting to main pigeon netting.

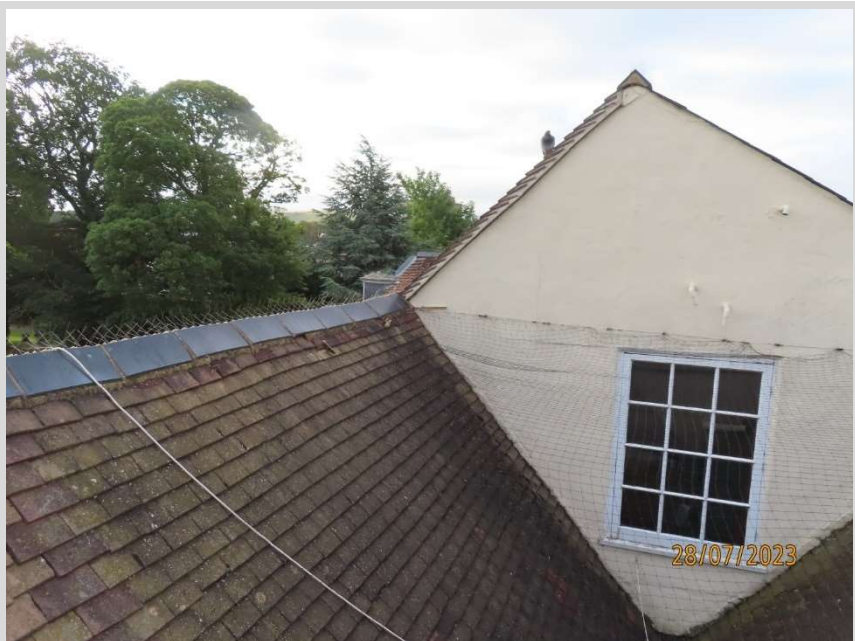
PHOTO 11.2.27a:

- 11.2.27 The roof tiles are continuous and generally evenly pitched, although there is evidence of patch repairs noted by a discontinuous colour in the tiled surfaces. The ridge tiles do require minor repointing.

Displaced pointing beneath ridge tiles which requires repair.

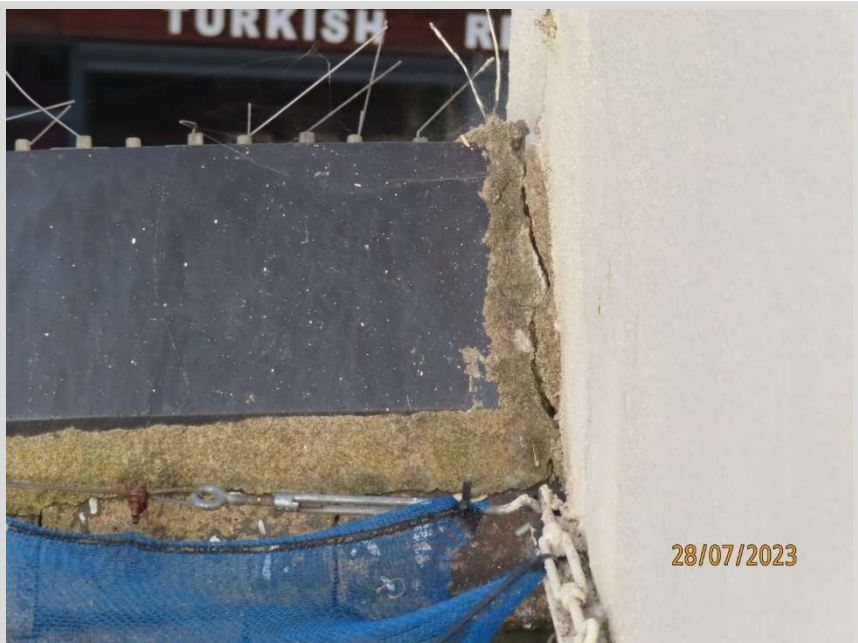
PHOTO 11.2.27b:

Cracked pointing on
ridge tile with junction to
chimney abutment.

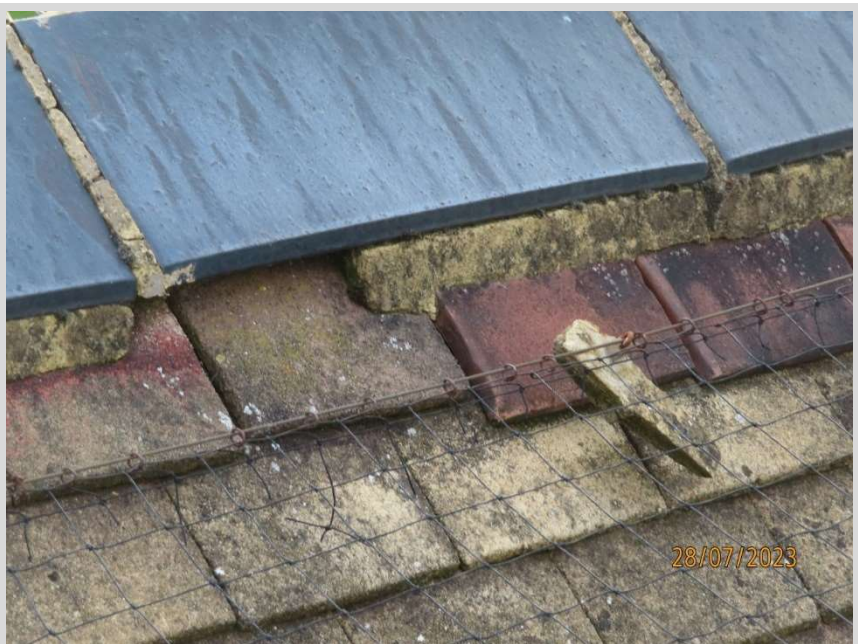
PHOTO 11.2.27c:

Cracked pointing
underneath ridge tile.

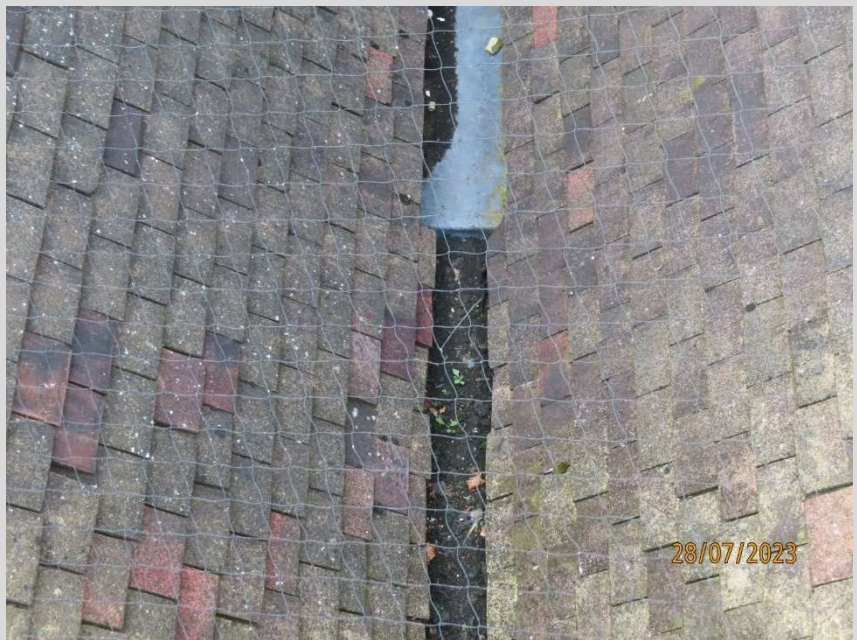
JPEG No: IMG_5766

- 11.2.29 The lead lined valley gutter is rather narrow and prone to blockage as noted by the silt debris along its length which requires cleaning through.

Blocked valley gutter.

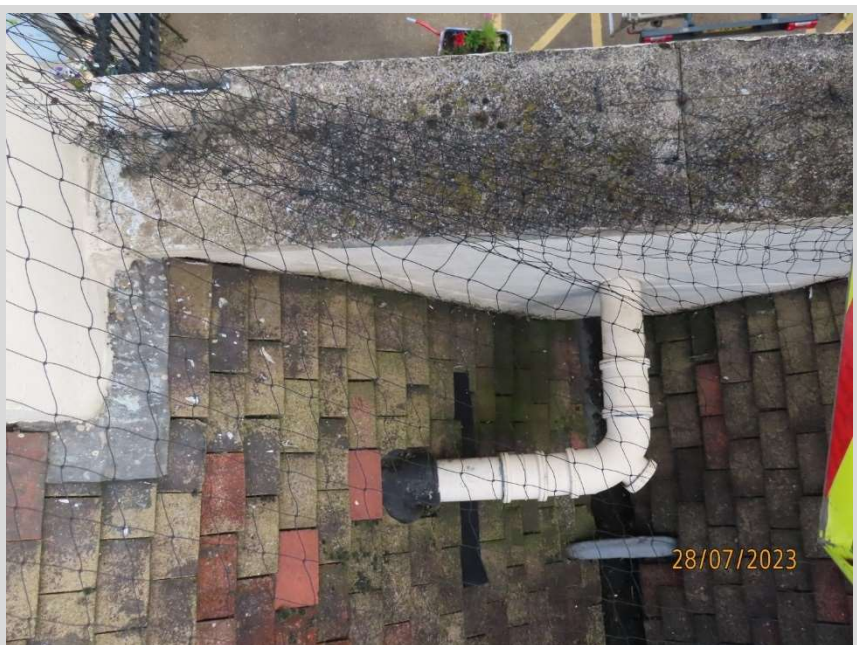
PHOTO 11.2.30:

- 11.2.30 There is a rainwater drainage pipe routed through the tiling and discharging through the gable wall to an external hopper head; this is a rather unusual arrangement but appears to be effective and does not require repair at present.

Rainwater drainage pipe
routed through roof tiling
into external hopper
head.

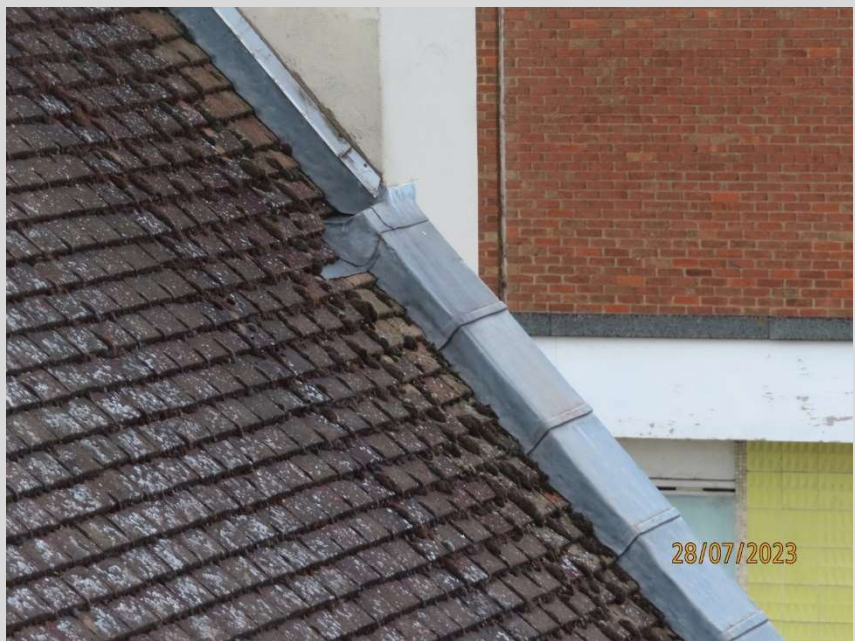
JPEG No: IMG_5727

Lead flashing and termination bar to rendered chimney stack which is separating from render and will allow water ingress into the structure below.

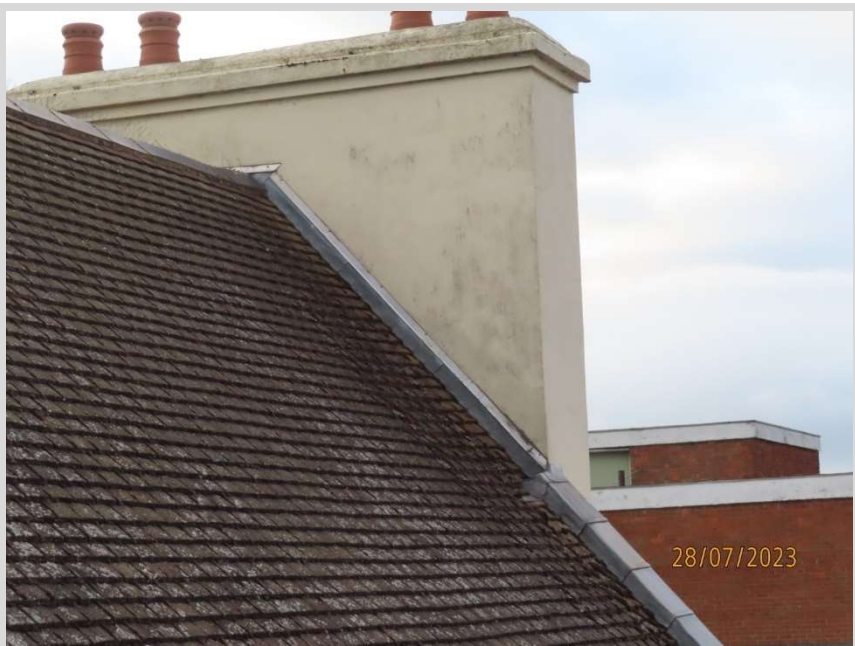
**PHOTO 11.2.33b:**

Lead flashing and termination bar to rendered chimney stack which is separating from render and will allow water ingress into the structure below.

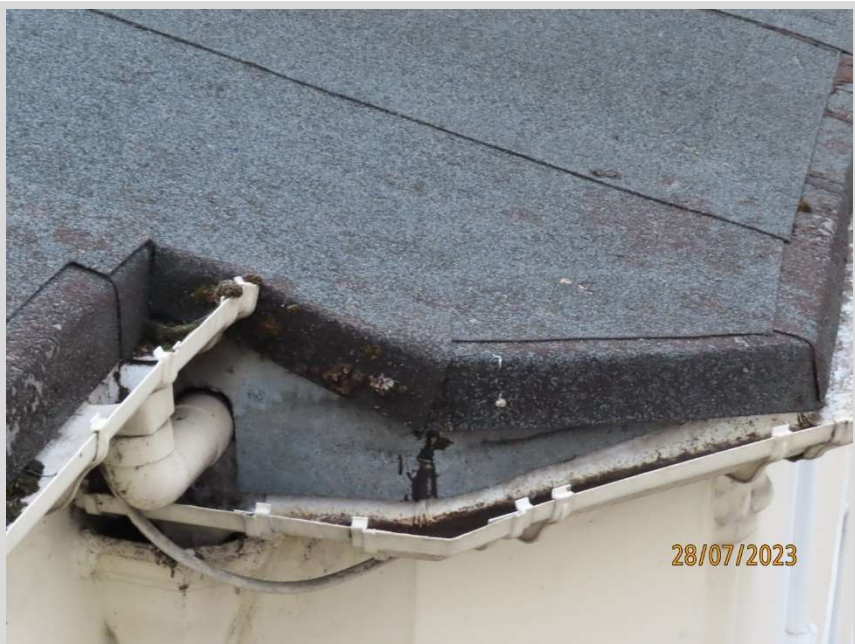
JPEG No: IMG_5684

Badly eroded edge detail to the felt roof coverings above the gutter line.

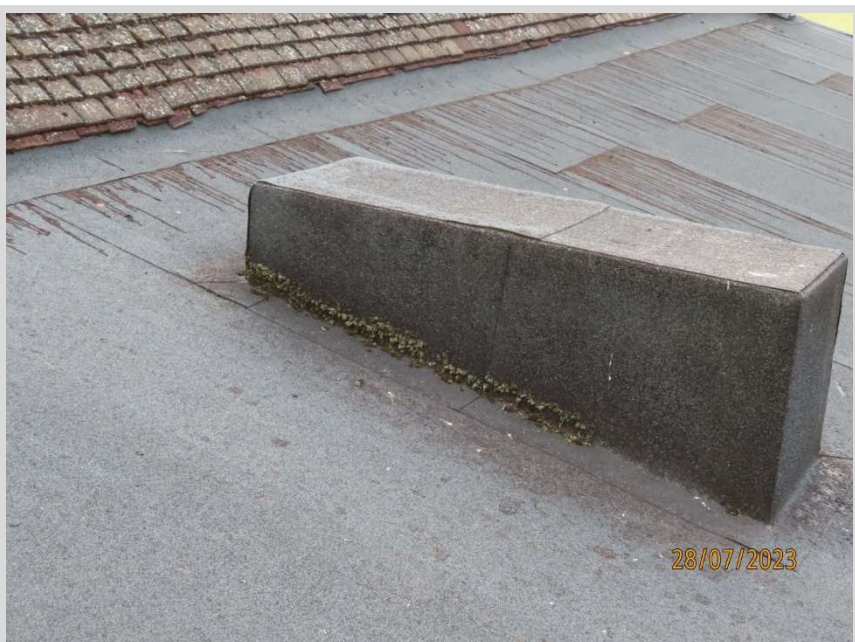
PHOTO 11.2.38:

- 11.2.38 There is also a raised bulkhead detail which possibly encloses a redundant chimney flue, but nevertheless will need re-covering at the same time.

Raised felt bulkhead detail on sloping felt roof.

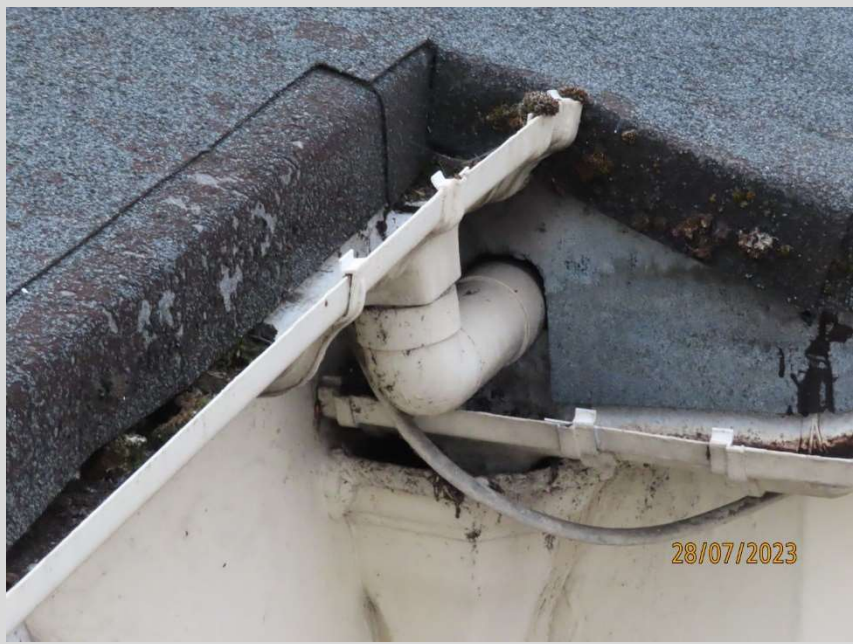
PHOTO 11.2.40:

- 11.2.40 There is also a 100mm diameter drainage pipe running through the gable wall which is connected to one of the gutters and tends to indicate that the rainwater pipe drains into the roof void and then discharges elsewhere. This needs to be traced, as this may be a source of the internal water damage affecting the first floor rooms below.

Rainwater drainage pipe
routed into roof void
through wall which
needs tracing.

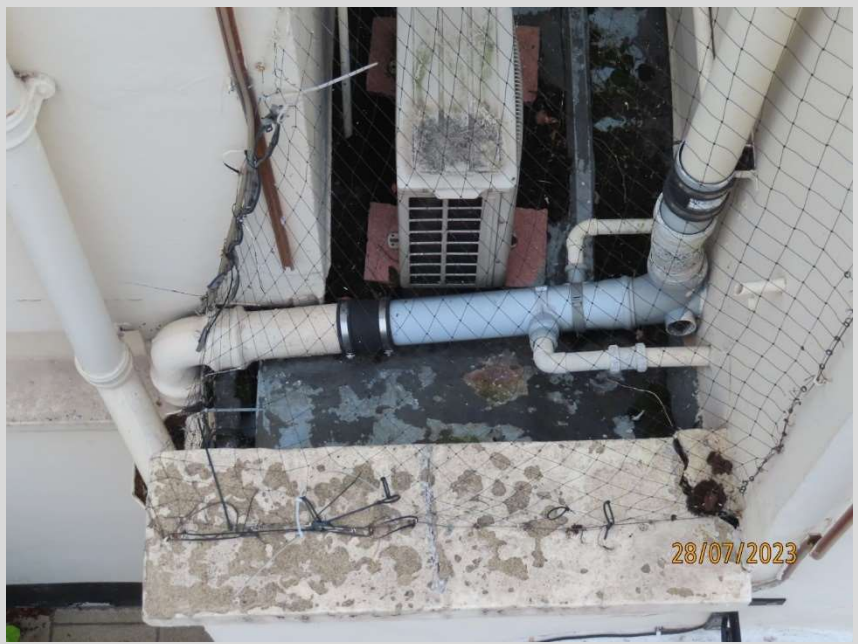
JPEG No: IMG_5688

Congested flat roof area with heat exchanger, displaced drainage pipe joint and failed roof coverings.

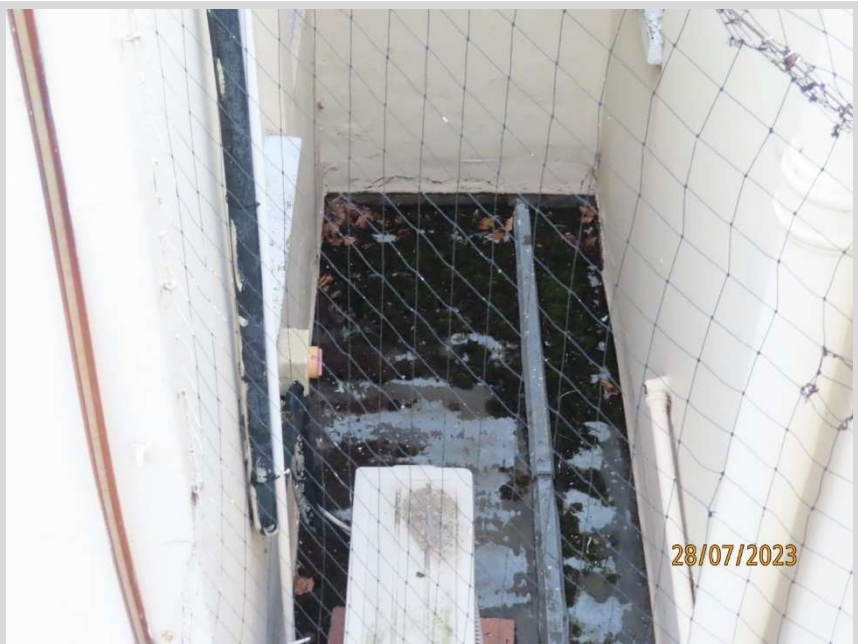
**PHOTO 11.2.46b:**

Moss and silt debris on roof.

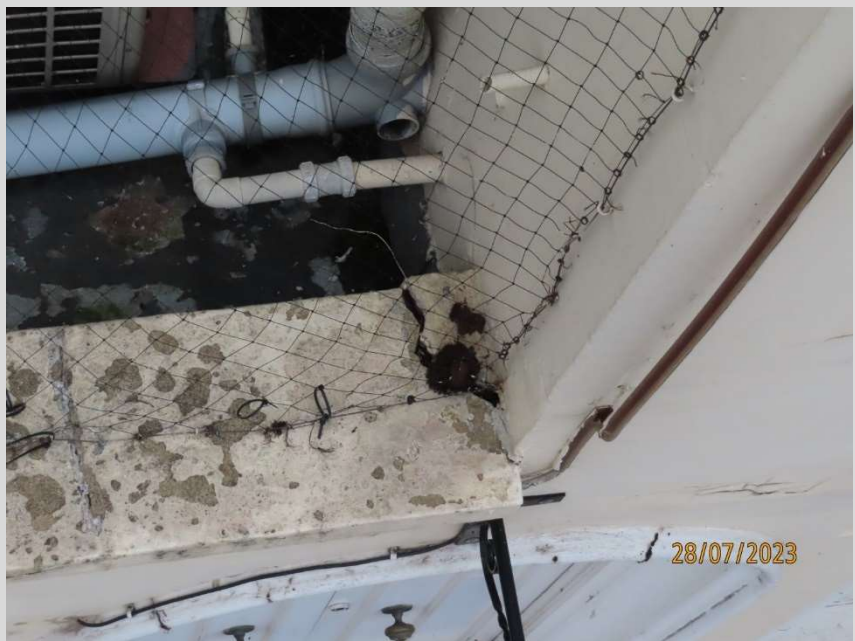
PHOTO 11.2.47:

- 11.2.47 Part of the concrete coping is cracked and displaced' leaving a gap in the coping which will be allowing some rainwater to drain into the masonry wall below. This needs repair as it will be a source of water ingress into the structure and internal dampness. Judging by the moss growth around the crack this defect appears to be quite old.

Cracked coping which allows water into the structure.

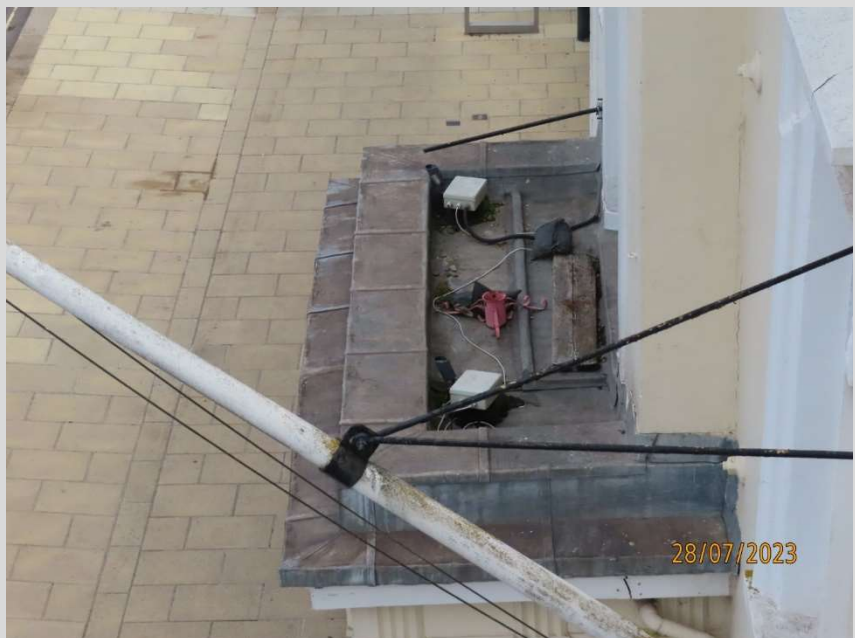
JPEG No: IMG_5742

- 11.2.48 This roof is lead covered, it has some minor debris on it and the rainwater outlet point is quite small, but the lead coverings appear to be in good condition for the time being. The abutment flashings along the main wall will need checking periodically, just in case there is some separation from the wall due to the portico structure leaning out and separating from the main wall itself. This could be achieved by reinstating the monitoring process.

Lead coverings over entrance portico.

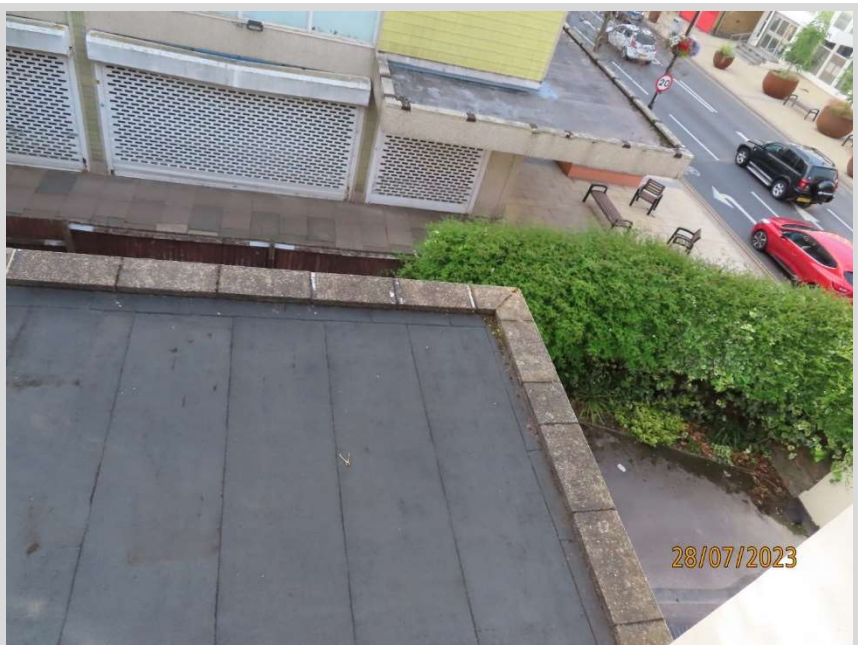
JPEG No: IMG_5814

- 11.2.49 This roof is finished with green mineral felt surrounded by a small, raised parapet wall capped with concrete copings. The coping stone joints require cleaning and repointing, as they are slightly open jointed with moss growing through them. This indicates they are retaining water which, in the longer term, can penetrate into the wall structure and lead to internal dampness.

Flat roof to north-eastern side. Note: coping stone joints require repair and repointing.

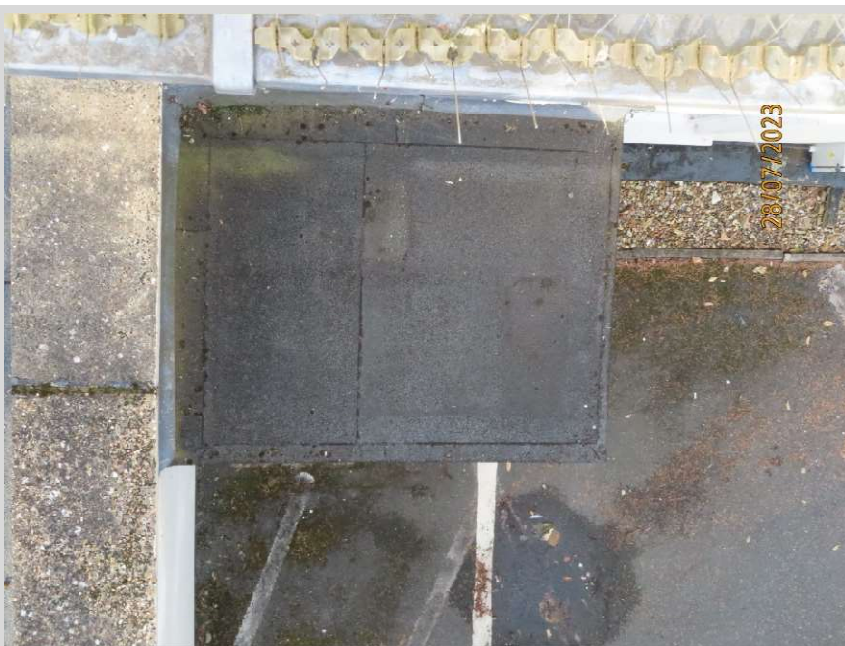
PHOTO 11.2.51:

11.2.51 There is a smaller lower felt roof over the entrance door which is in similar condition.

Flat roof over entrance porch.

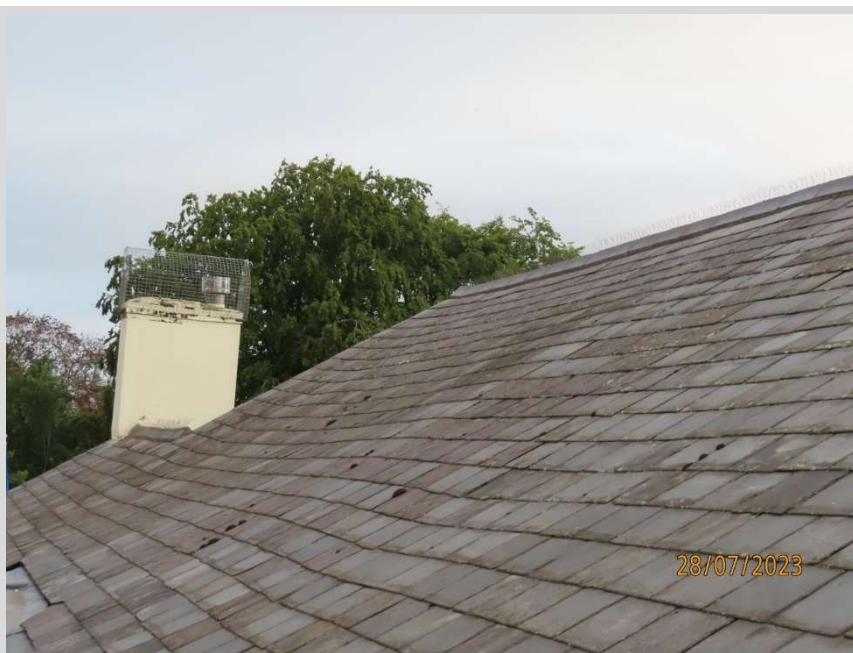
PHOTO 12.1.3:

General view of left chimney.
