Dunstable Town Council
Grove House
76 High Street North
Dunstable
Bedfordshire
LU6 1NF

Date: 19 June 2024

A G E N D A

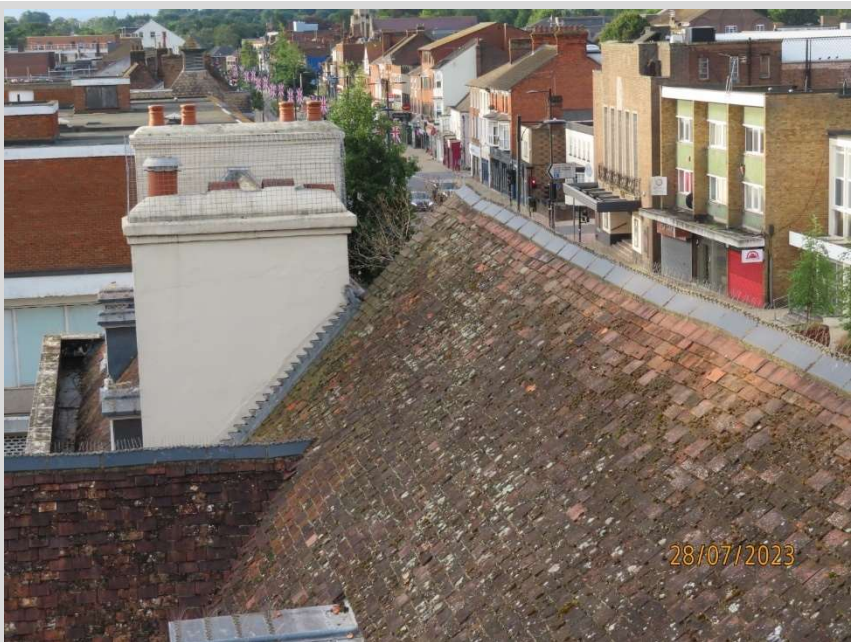
PHOTO 12.1.4:

- 12.1.4 The central chimney is located to the left of the small turret roof, over the Mayor's Parlour. This is a larger stack thought to provide four flues. The stack is formed in masonry which is rendered to finish with banding courses at high level. All of the flues are capped and assumed to be redundant.

General view of central chimney stack.

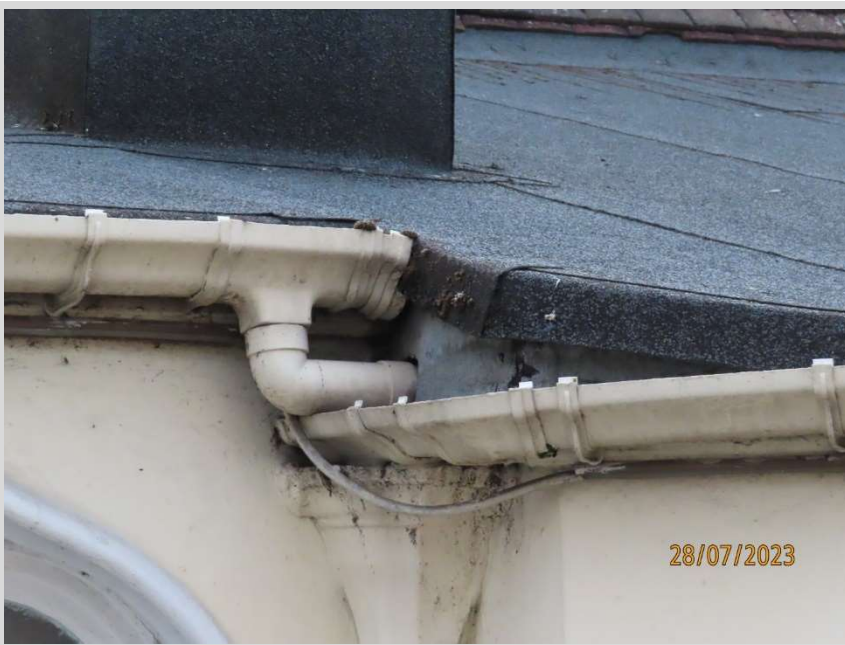
Rainwater gutters below west facing felt roof with drainage pipe routed into roof void and lower gutter section blocking cast iron hopper head.

13.3.1 Gutters should fall evenly towards the outlets and regular checks should be made to ensure that they are clear of debris and sediment. Any leaking joints should be remade. Brackets should be checked for defects and repaired/renewed as appropriate. Cracked or broken sections of gutter and downpipe should be renewed to prevent damp penetration. Ensure that rainwater drainage arrangements are operating efficiently.

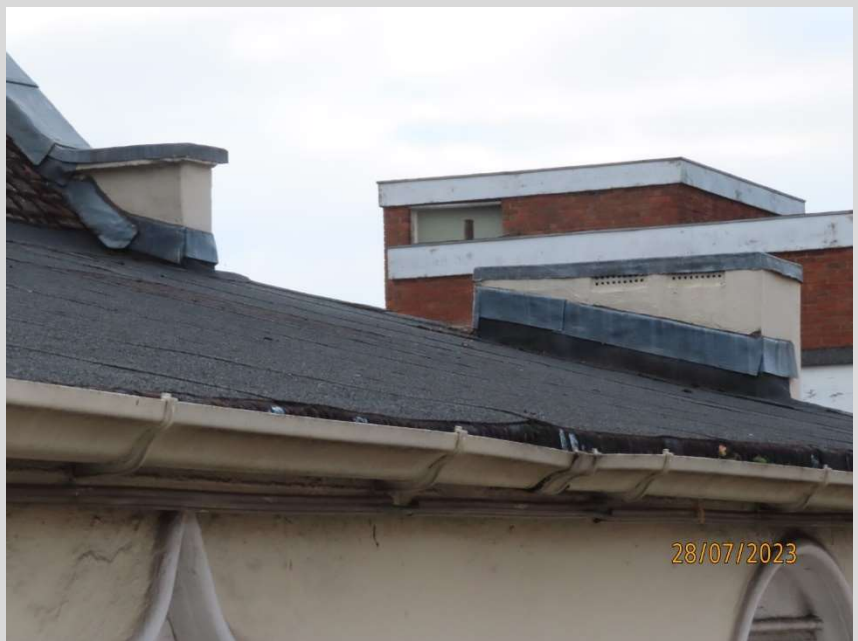
PHOTO 13.2.6b:

Displaced gutter joint to
west elevation.

- 13.2.5 At the same time any displaced joints or broken sections should either be repaired or replaced.
- 13.2.6 Over the years, there have been various alterations to the gutters, which to some degree have not been executed very well and possibly encouraging water retention within the building structures.

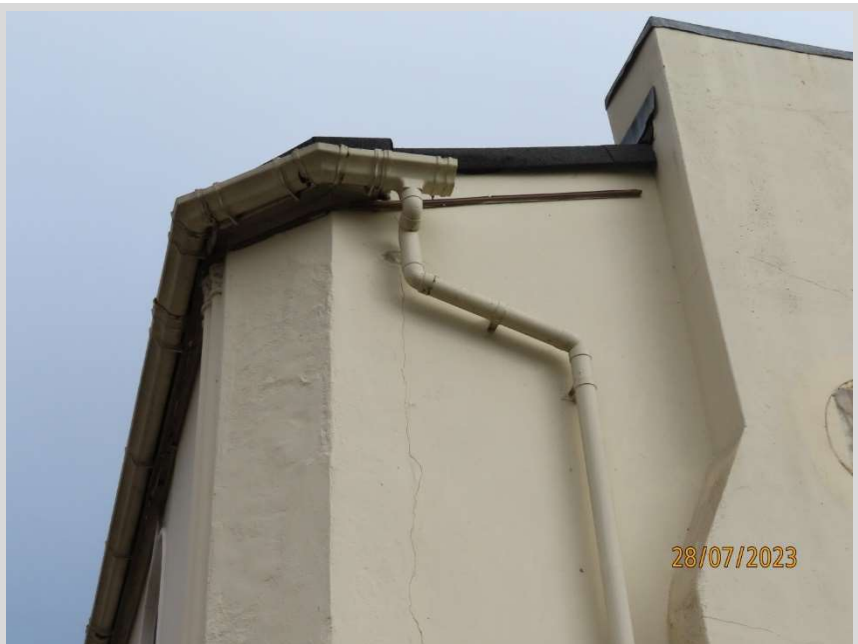
PHOTO 13.2.6c:

Rainwater downpipe
connections draining
front gutters.

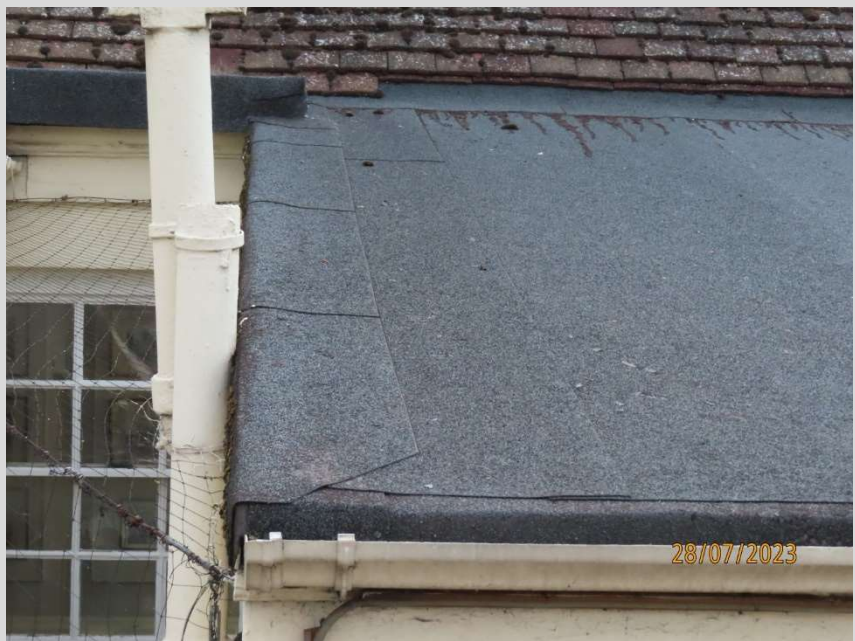
PHOTO 13.2.6d:

Soil stacks fitted to front wall which appear to drain into rainwater disposal systems below.

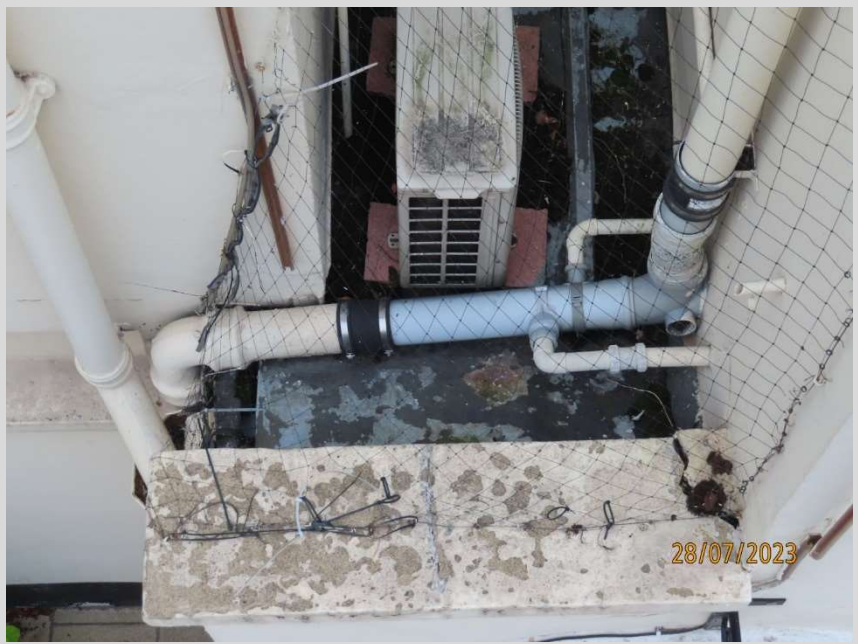
PHOTO 13.2.6f:

Waste water disposal
pipes which appear to
drain to side of
extension.

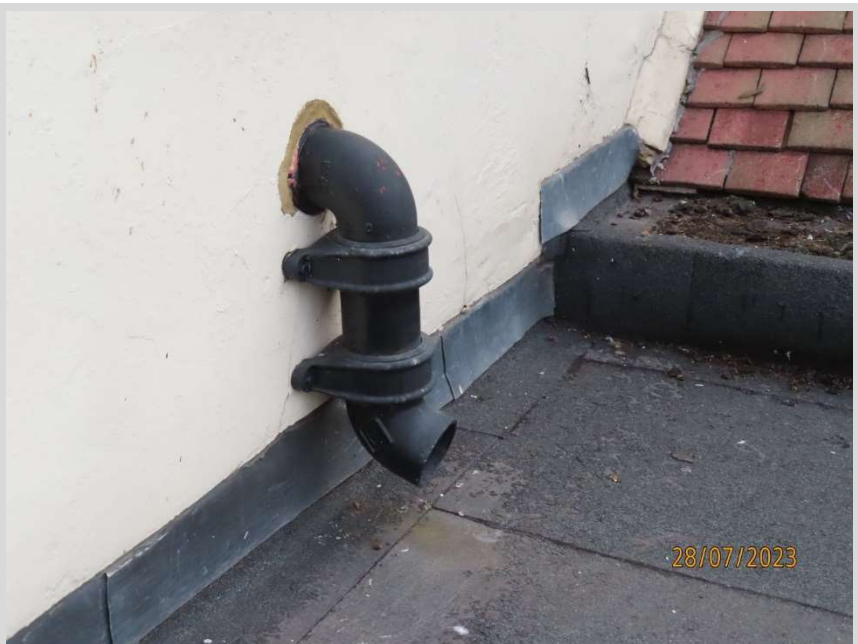
PHOTO 13.2.6g:

Cast iron drainage pipe
which drains onto flat
roof on front elevation.

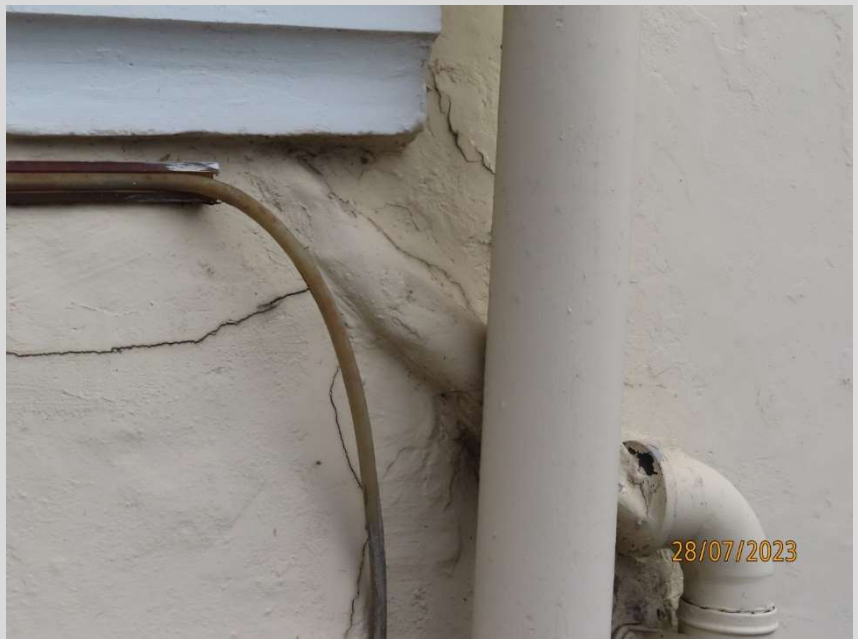
PHOTO 13.2.6h:

Old lead drainage pipe
embedded in rendered
wall crushed but
connected to uPVC
elbow.

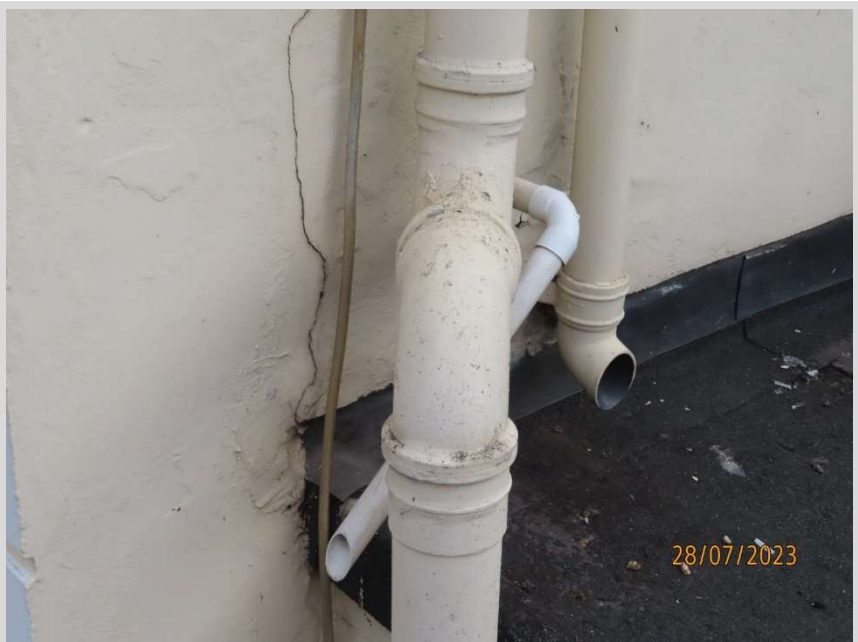
PHOTO 13.2.6i:

Wastepipe outlet
draining into external
rainwater hopper head
with rainwater outlet
adjacent and soil pipe
connection in front.

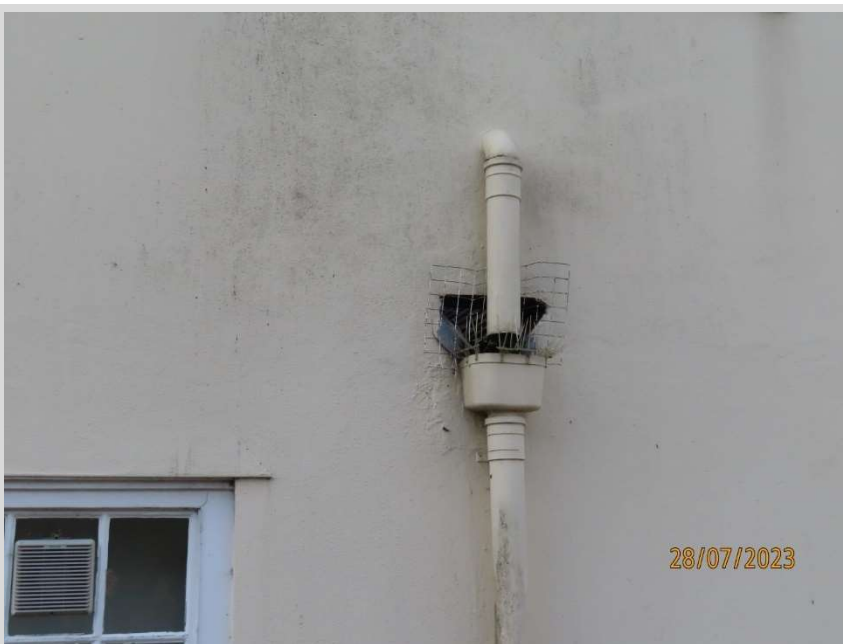
PHOTO 13.2.6j:

North facing gable with upper rainwater pipe draining through sloping roof behind wall and external hopper heads draining to valley gutter, which is full of leaf debris and silt.

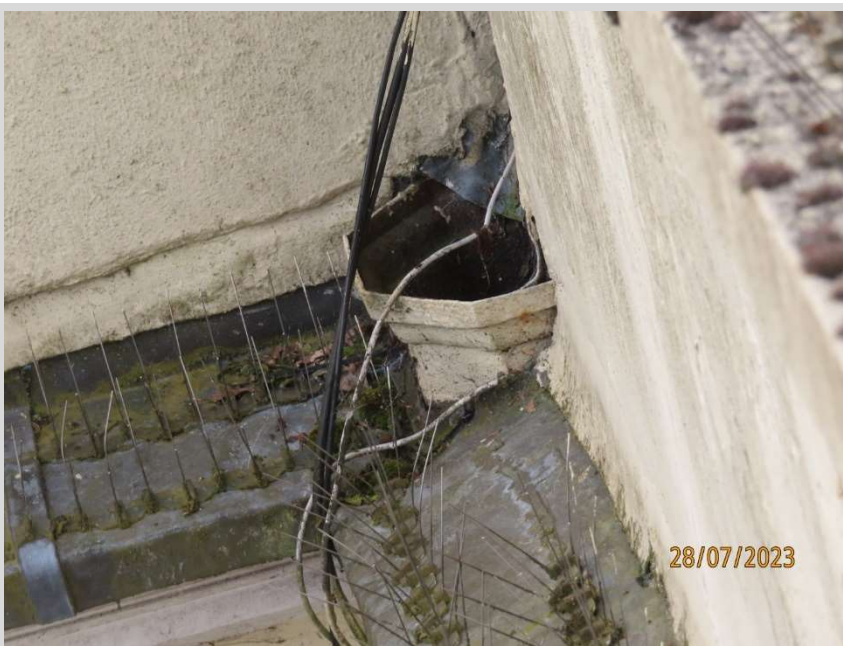
**PHOTO 13.2.6k:**

Corroded metal hopper head which is draining through rear parapet wall.

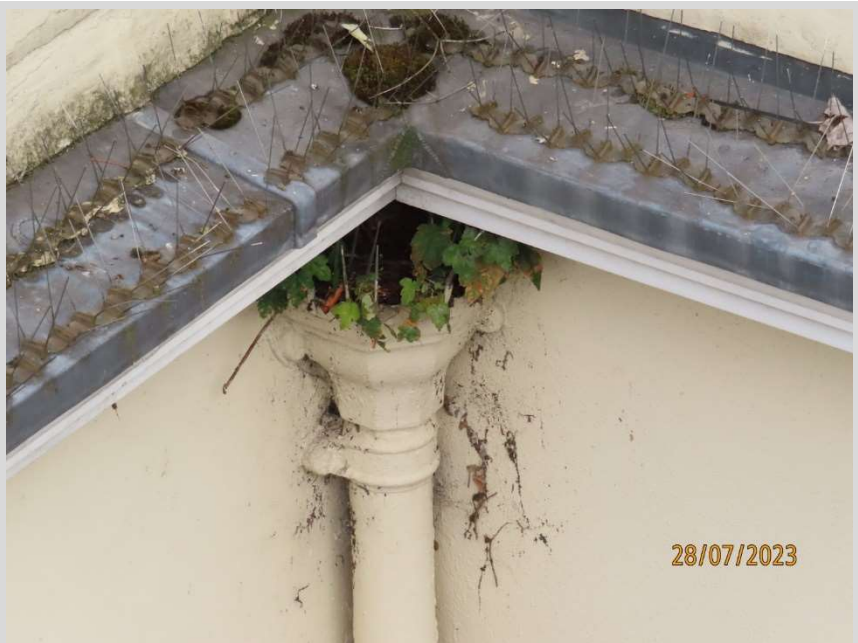
PHOTO 13.2.6i:

Blocked metal hopper head which is causing dampness in the wall face.

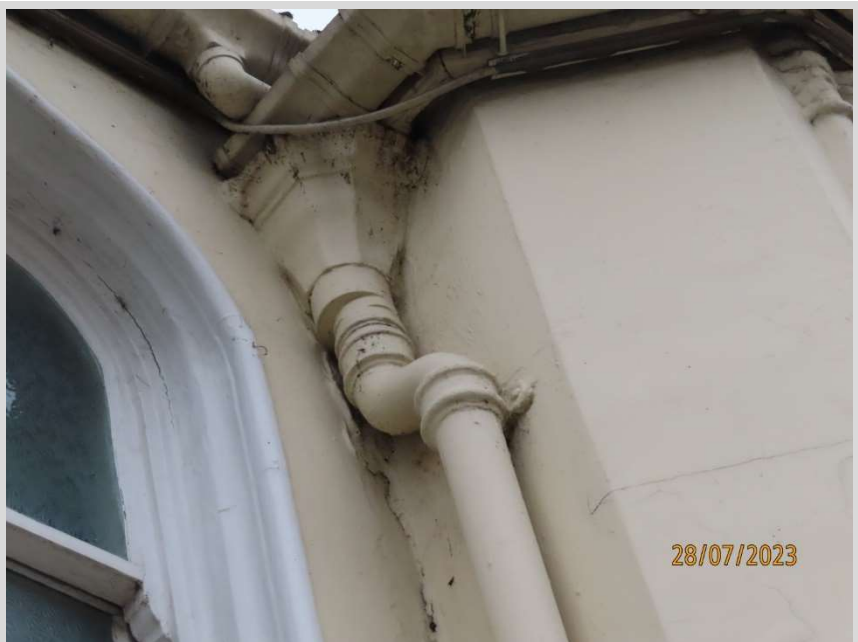
PHOTO 13.2.6m:

Blocked and redundant hopper head with damp render behind.

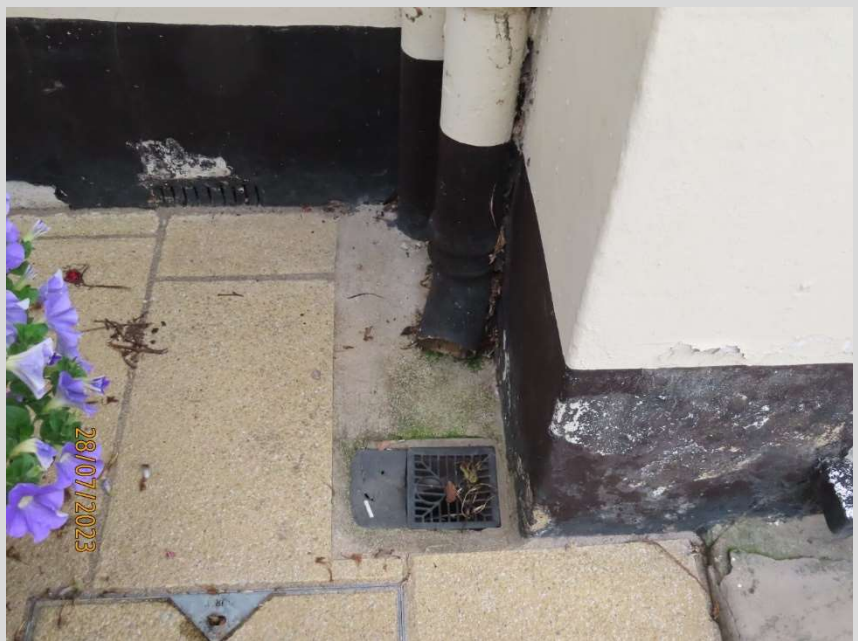
PHOTO 13.2.6n:

Rainwater pipe draining onto paving with clear water retention on path, as evidenced by more staining and dampness in black painted plinth.

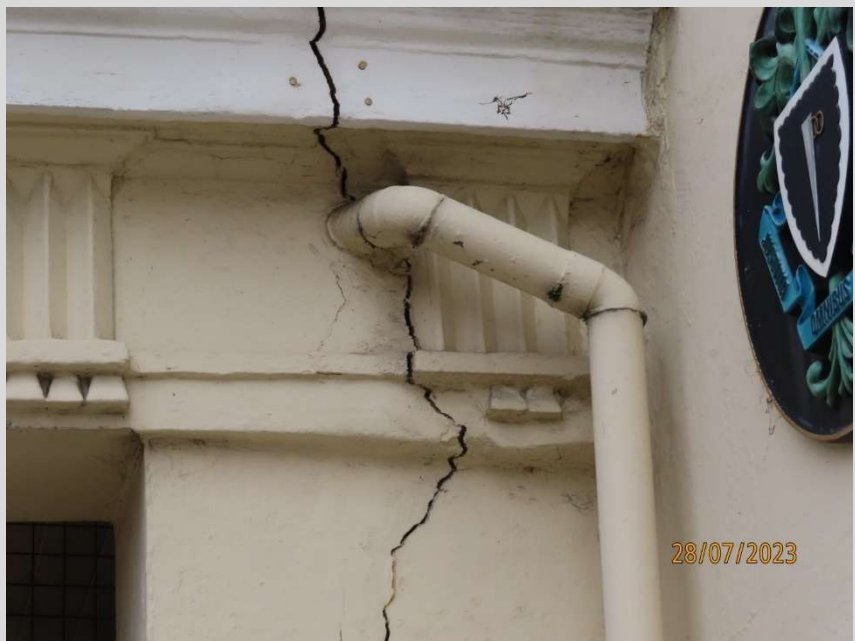
PHOTO 13.2.6p:

Rainwater outlet from
entrance portico with
separation cracks
adjacent.

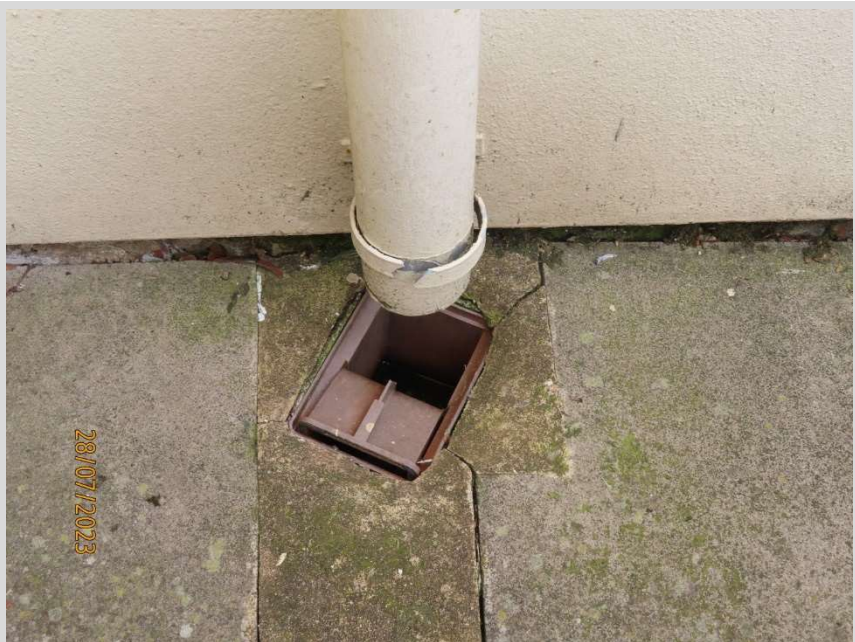
PHOTO 13.2.6q:

Broken gulley grating on
north elevation.

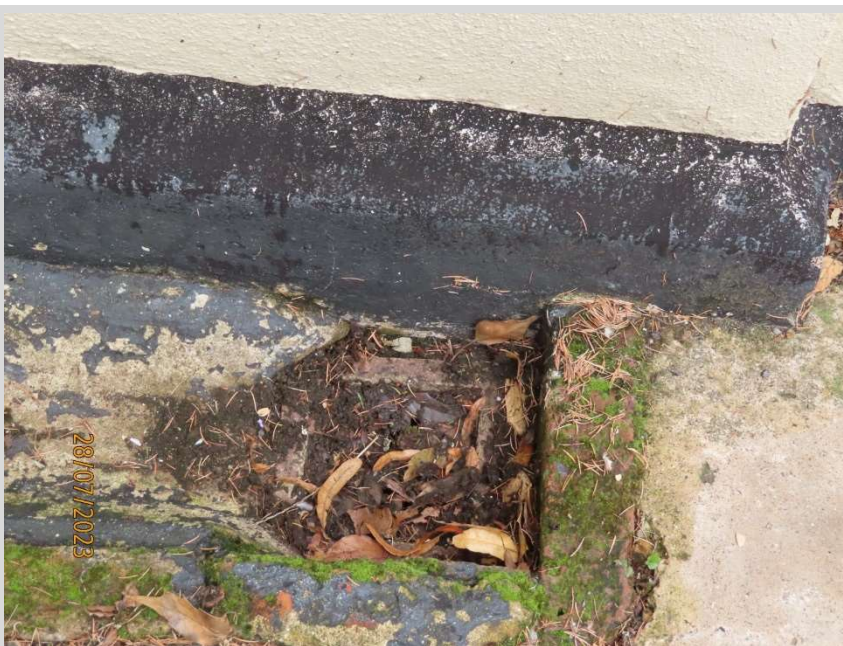
PHOTO 13.2.6s:

Blocked rainwater gulley
outlet.

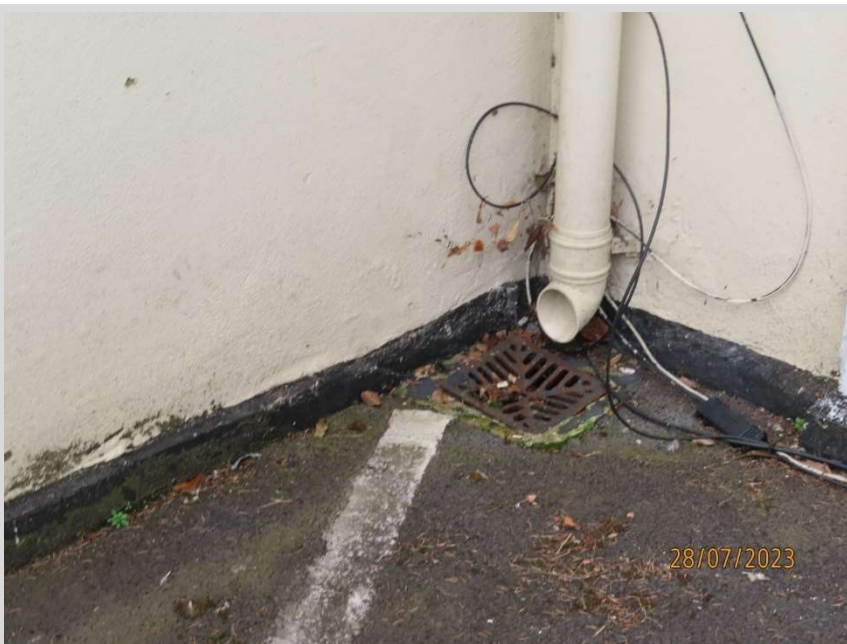
PHOTO 13.2.6t:

Rainwater downpipe
draining to open gully.

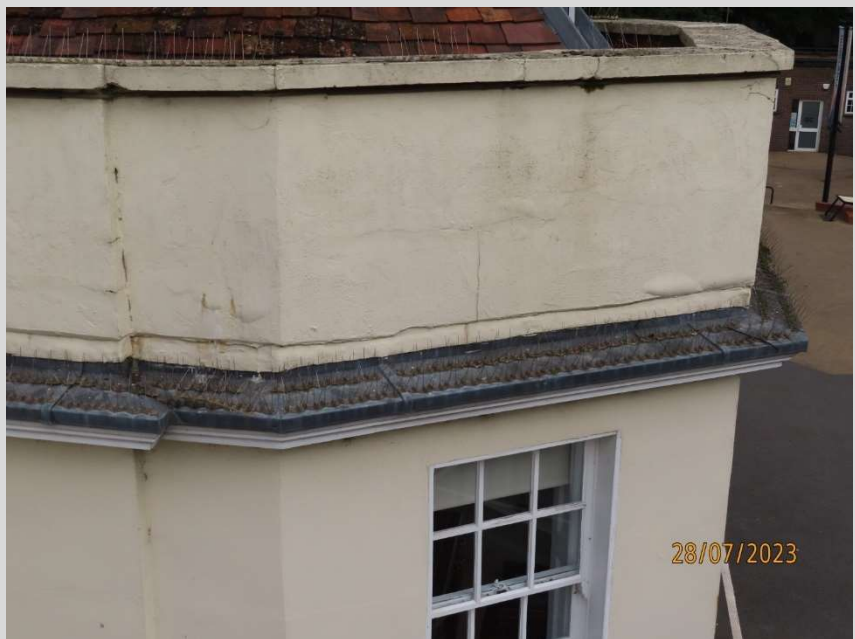
- 14.2.5 This property displays cracked render finishes on all elevations. In many places, the paint applied to the render is also bubbling and lifting, further indicating that water is trapped behind.

Cracked render and bubbling paintwork on parapet wall to rear bay.

- 14.2.6 As a short term measure, the cracked areas should be carefully repaired as soon as possible to try and reduce the amount of water entering the building.
- 14.2.7 In the longer term, we recommend that the rendering is renewed with a more breathable render system which would enable evaporation to take place.
- 14.2.8 On the front elevation, there are cracks between the ground and first floor window openings adjacent to the window arches and window cills.

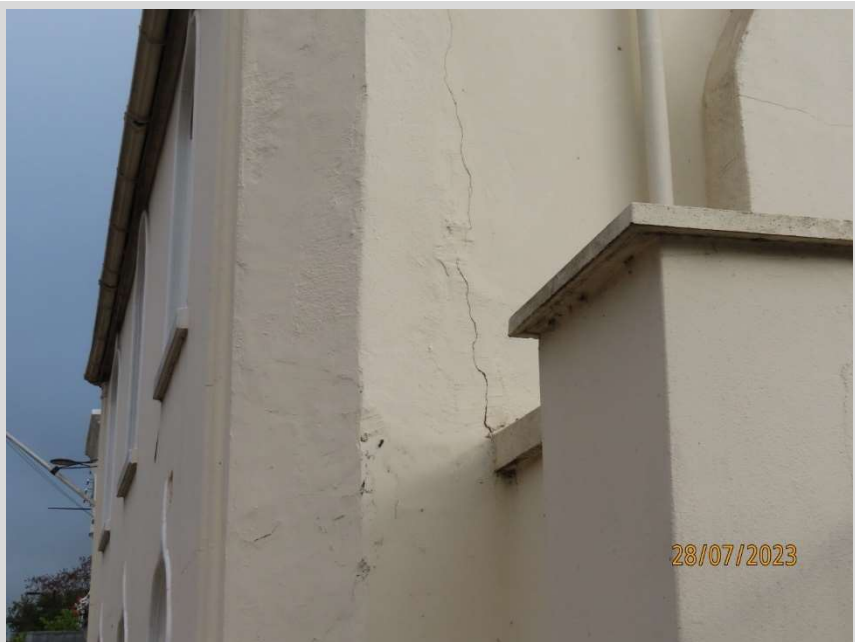
PHOTO 14.2.5b:

Cracking on south elevation on main gable wall with peeling paintwork below on corner of building.

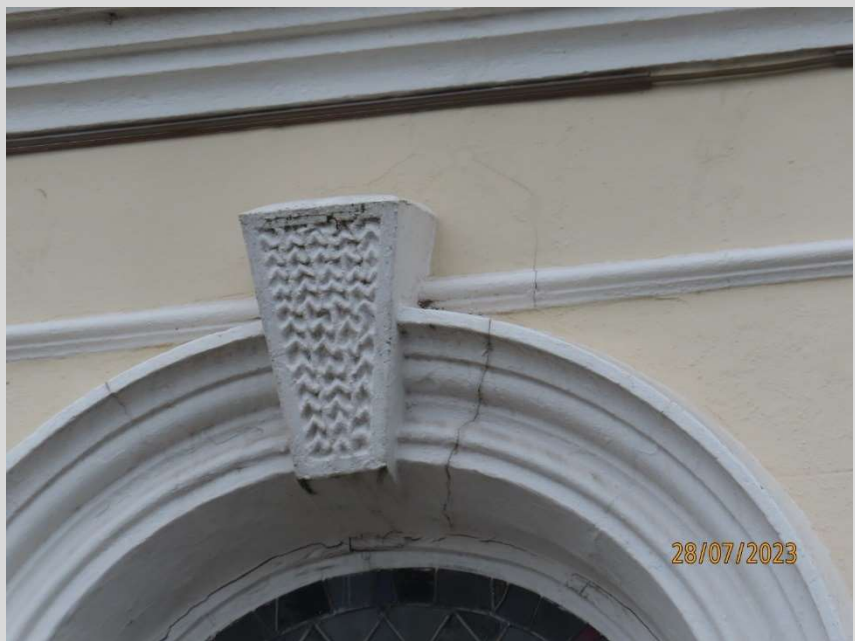
PHOTO 14.2.8a:

Cracked first floor window head which extends into render below parapet.

- 14.2.9 We believe that over the years the loadbearing timbers built into the masonry walls have decayed due to their age, but also long term water penetration issues and as a result they have compressed slightly enabling displacement of the masonry between the windows on each floor. The movement is not severe and is likely to have been present for many years, however, it is important to repair the render prevent the deterioration becoming more serious.
- 14.2.10 At some point in the future the loadbearing timber should be checked so an assessment of the condition can be made to establish whether any repair will be required which will of course be subject to Listed Building Consent.

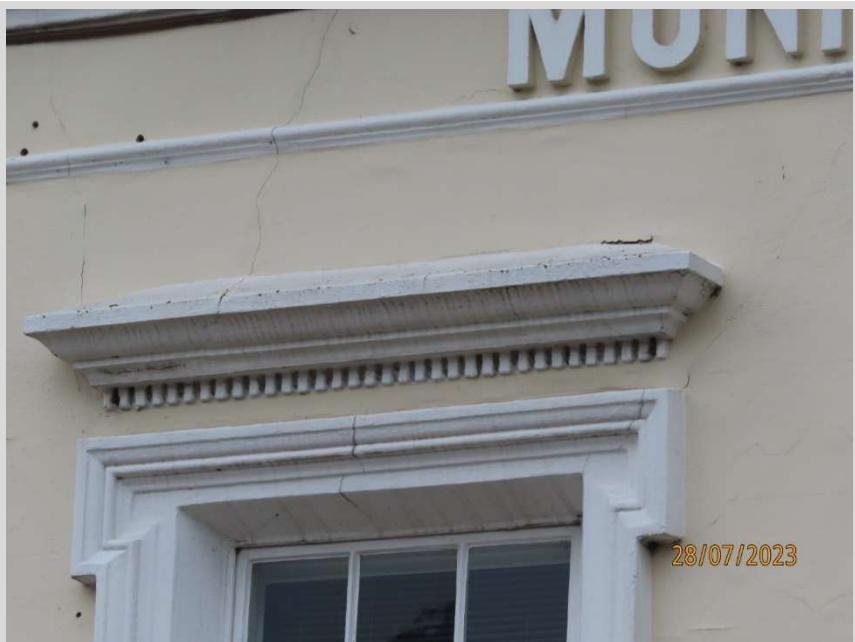
PHOTO 14.2.8b:

Cracked window head with further cracking on pediments and parapet above.

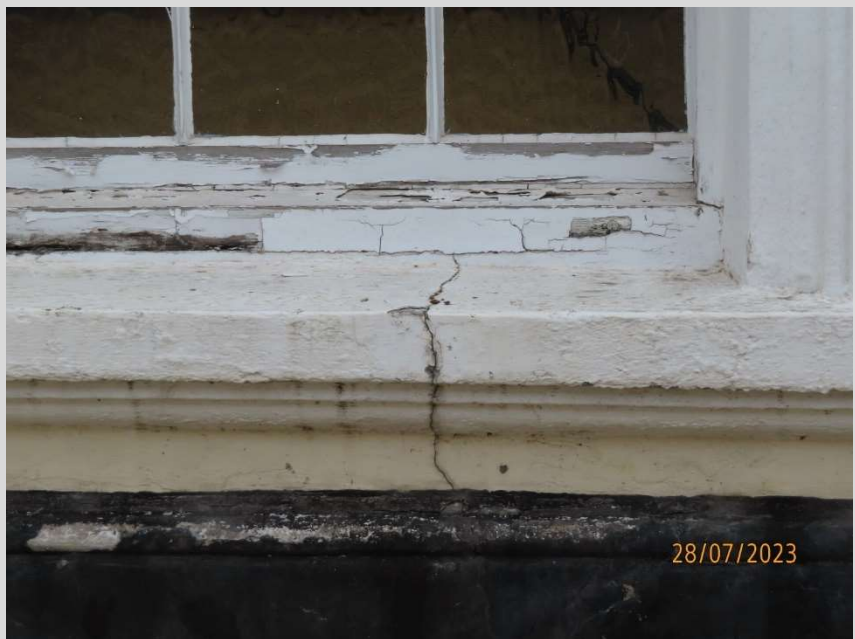
PHOTO 14.2.8c:

Crack through ground floor rendered window cills.

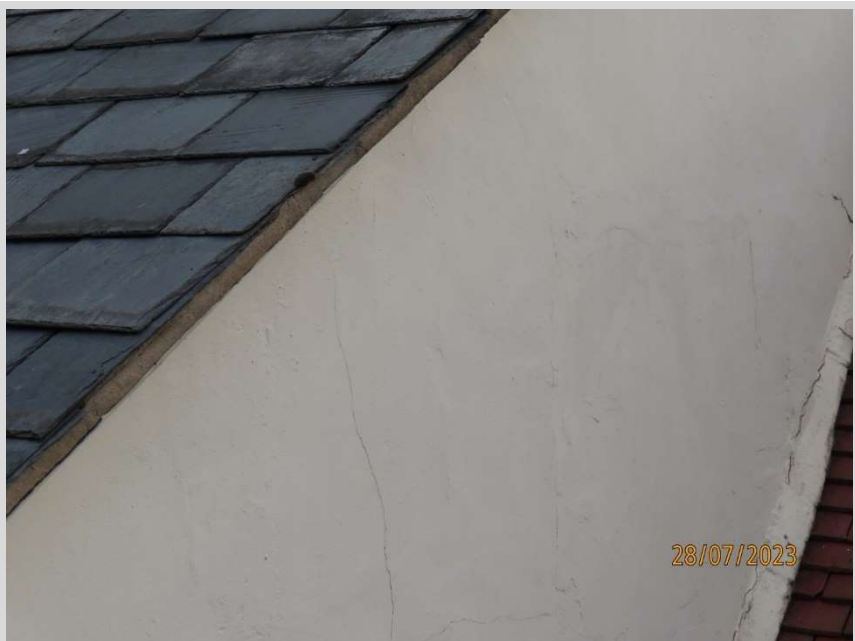
PHOTO 14.2.10a:

Hairline vertical cracking in south facing gable wall.

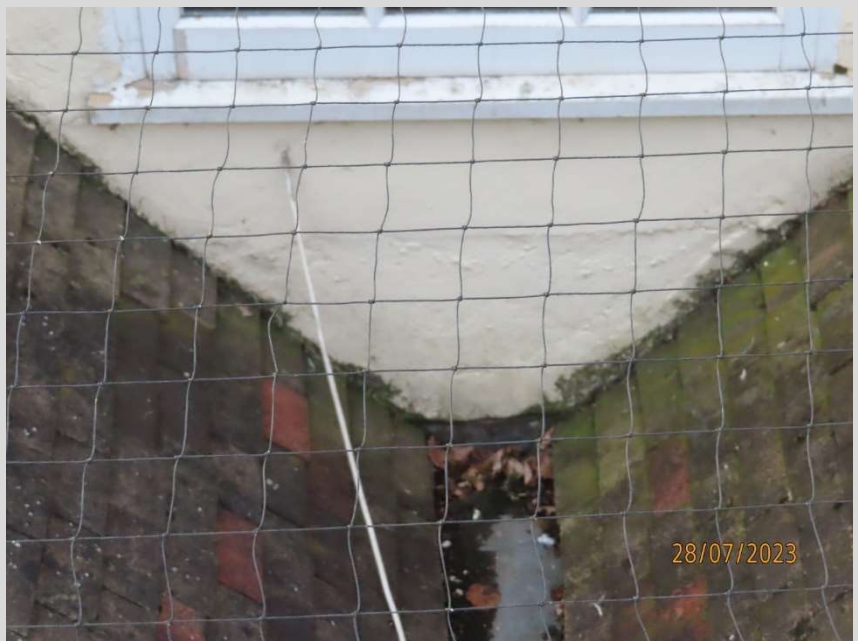
PHOTO 14.2.10b:

Damp render finishes
with water trapped
behind on north facing
gable wall overlooking
lower roofs.

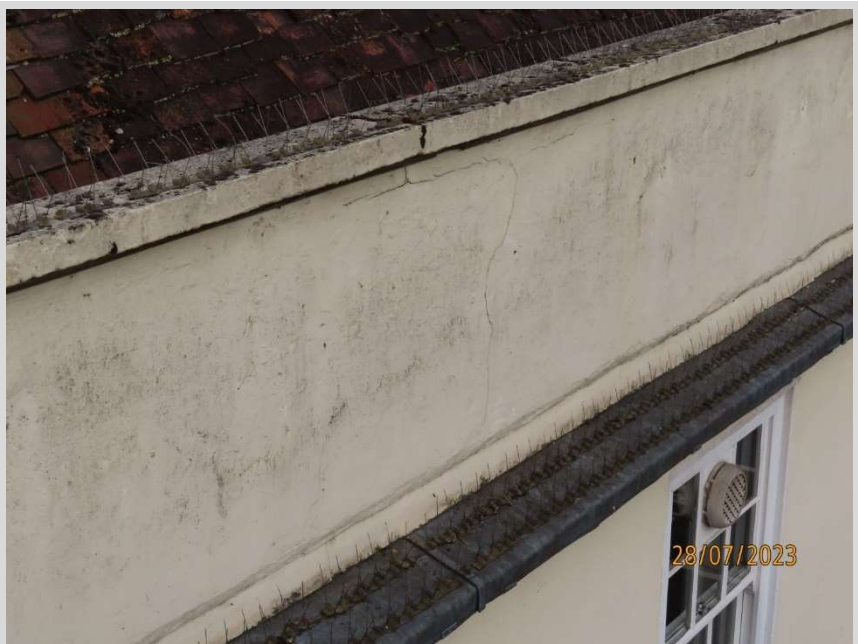
PHOTO 14.2.10c:

Typical crazing of render
on east facing parapet
wall.

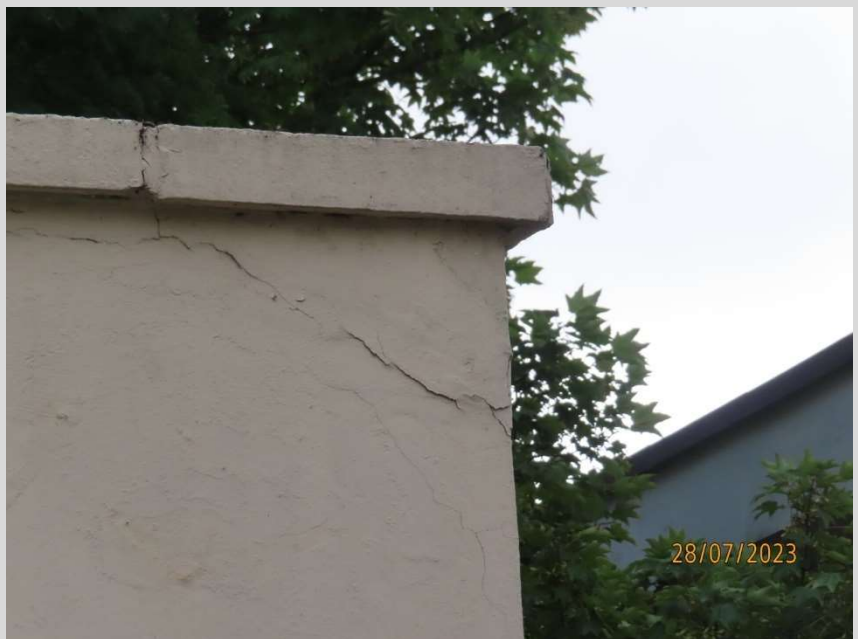
PHOTO 14.2.10d:

Cracked render on
north-east extension.

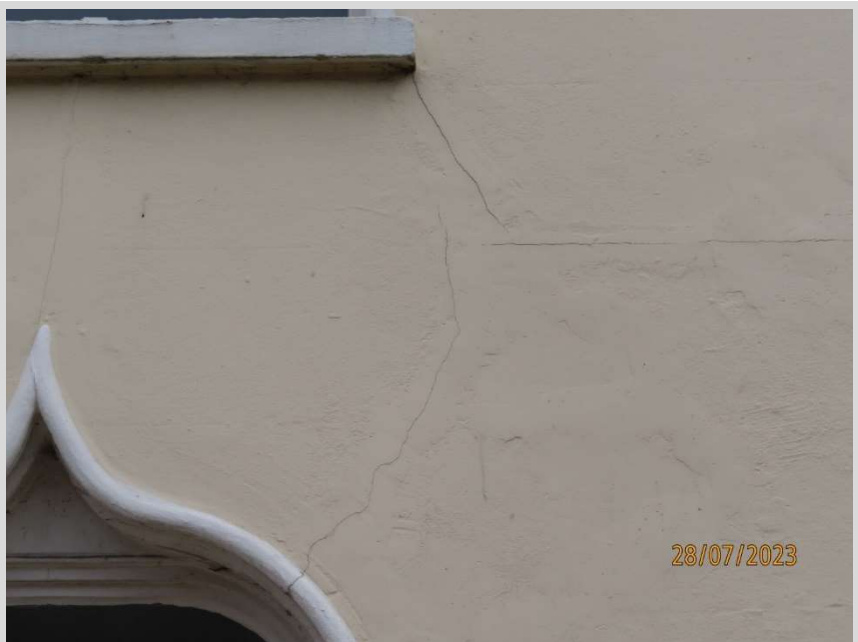
PHOTO 14.2.10e:

Typical cracks on west
elevation with uneven
render finishes behind.

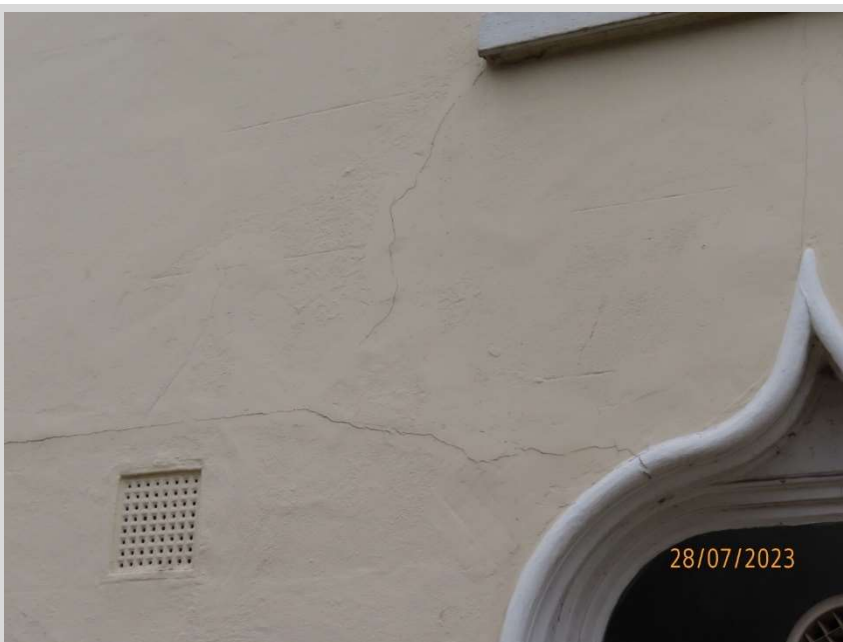
PHOTO 14.2.10f:

Typical cracks on west elevation with uneven render finishes behind.

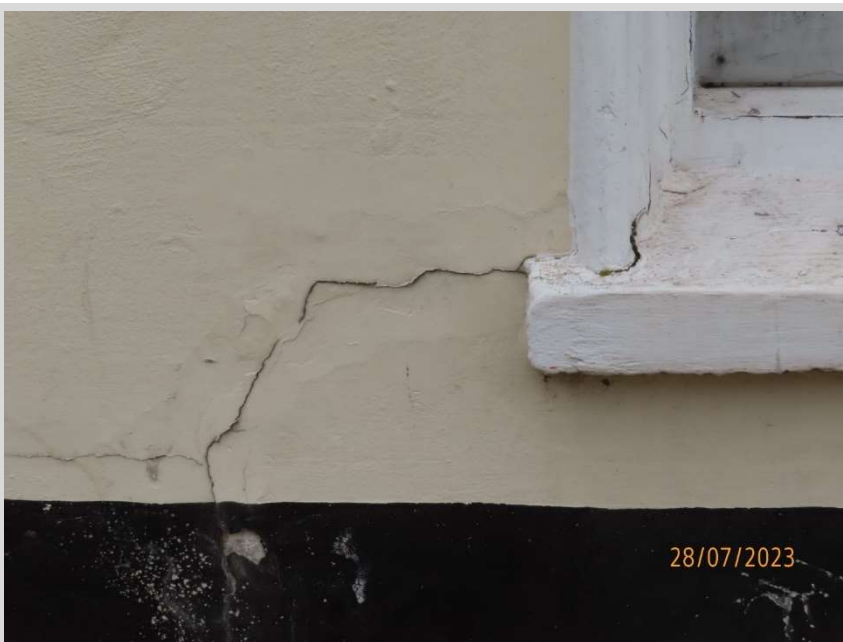
PHOTO 14.2.10g:

Typical cracks on west elevation with uneven render finishes behind.

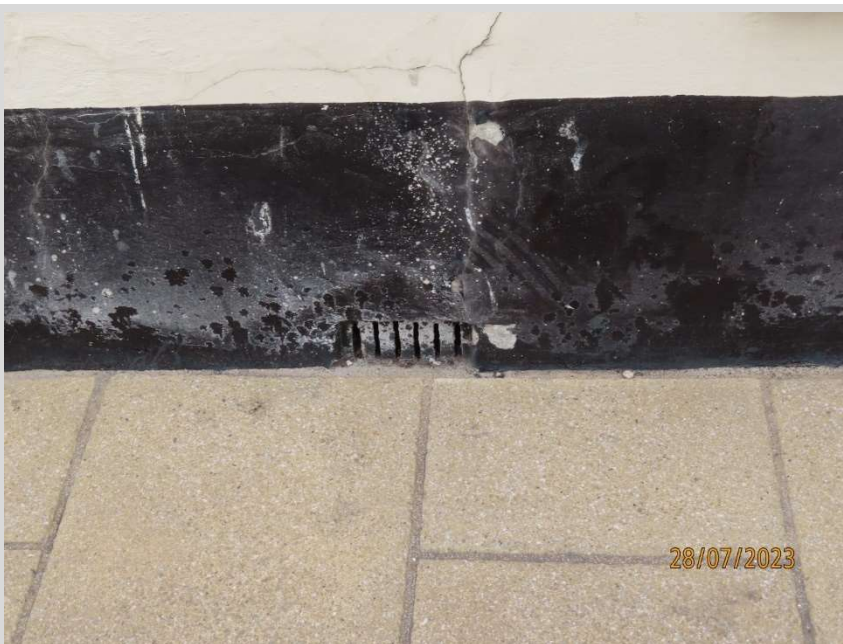
PHOTO 14.2.11:

- 14.2.11 The black painted ground floor plinths around the base of the property, adjoining the pavements, are also in poor condition; the paintwork finishes are failing, the air vents are partially blocked, and the render is cracked.

Failing plinth at base of wall.

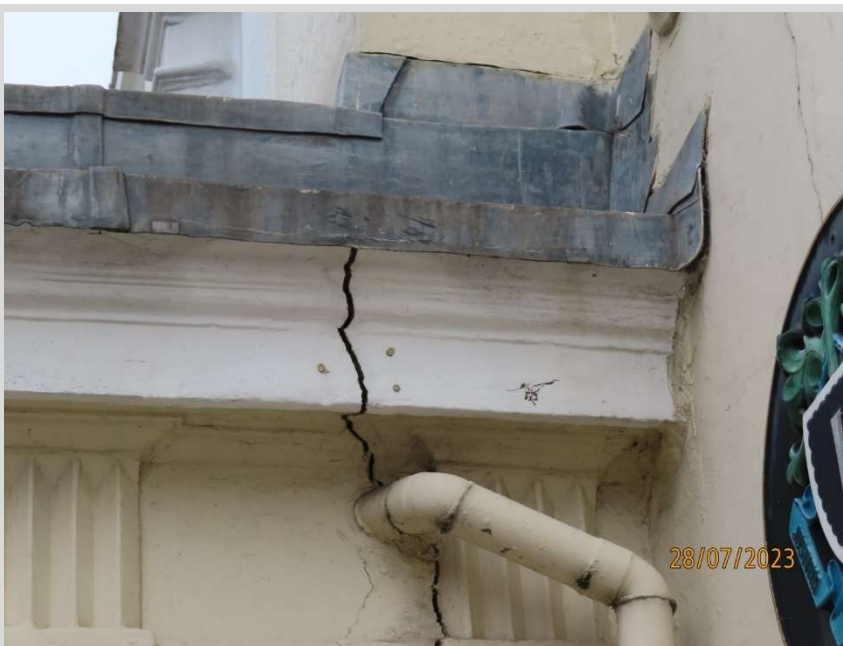
PHOTO 14.2.14a:

- 14.2.12 In addition to these observations, the external painted surfaces, which are quite extensive, are now due for redecoration which should be done once the repairs have been undertaken.
- 14.2.13 The entrance portico is separating away from the main building with vertical cracks at the junction to the main building; this movement has been monitored in the past and it is evident that, although quite noticeable, it did not appear to be progressive.
- 14.2.14 However, we recommend that the movement is monitored by measurement at least annually to either provide reassurance that no remedial work is necessary or ensure that any future movement is not overlooked.

Separation crack between the main building and the portico on the south side.

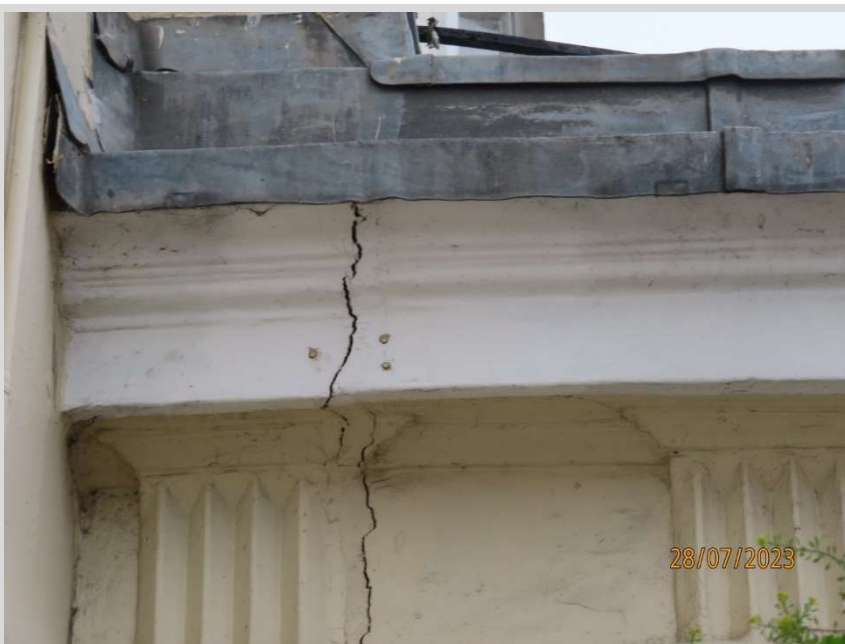
PHOTO 14.2.14b:

Separation crack
between the main
building and the portico
on the north side.

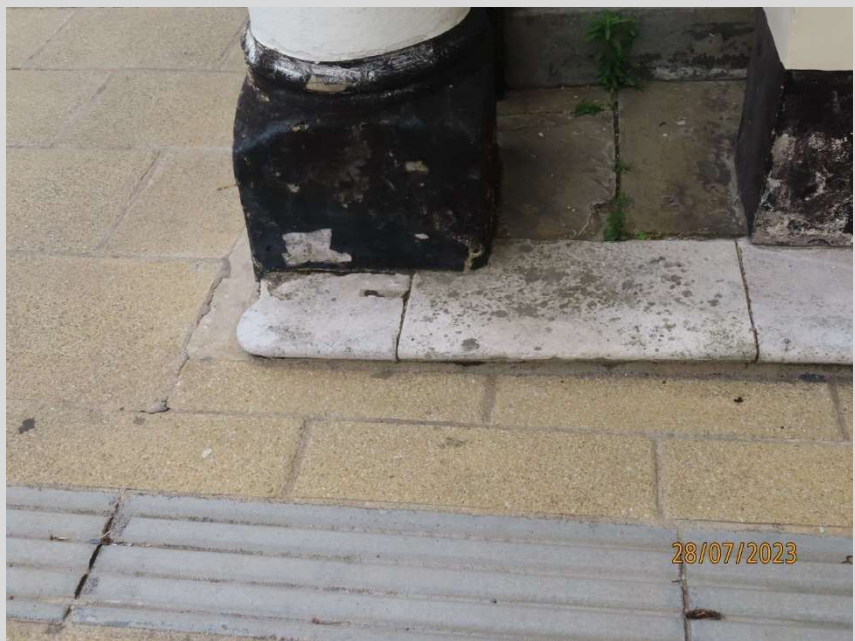
JPEG No: IMG_6028

Displacement of stone paving supporting the portico.

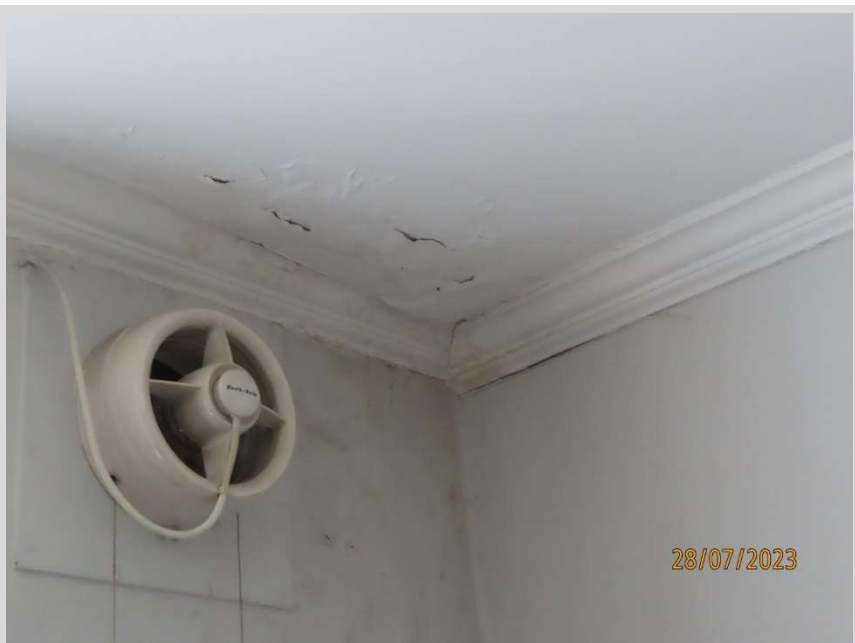
PHOTO 14.2.15a:

14.2.15 The descriptions of defects in Items 18.2.1 to 18.2.19 have manifested themselves internally with severe dampness to plaster and ceiling finishes in the first floor kitchen on the west elevation, and dampness within the offices to the east elevation at first floor level, as well as cracking within the offices on first floor north-west elevation and dampness at ground floor level to both the west elevation and internal walls to the rear as well as south and north gables.

Damp ceiling and wall plaster to first floor.

- 14.2.16 With respect to the internal dampness, our recommendations regarding roofs, parapet walls, valley gutters, rainwater goods and rendering repairs will address the internal damage and disrepair to the plaster and decorative finishes. However, the walls will take a long time to dry, and it may be some time before the interior areas can be redecorated.

- 14.2.17 Ideally, if possible, the damp plaster should be removed, this will be unsightly, but it is the fastest method of drying out the walls, it will also facilitate an internal inspection of the wall structures and enable exposure of any timbers built into the damp masonry to establish if they need repair too.

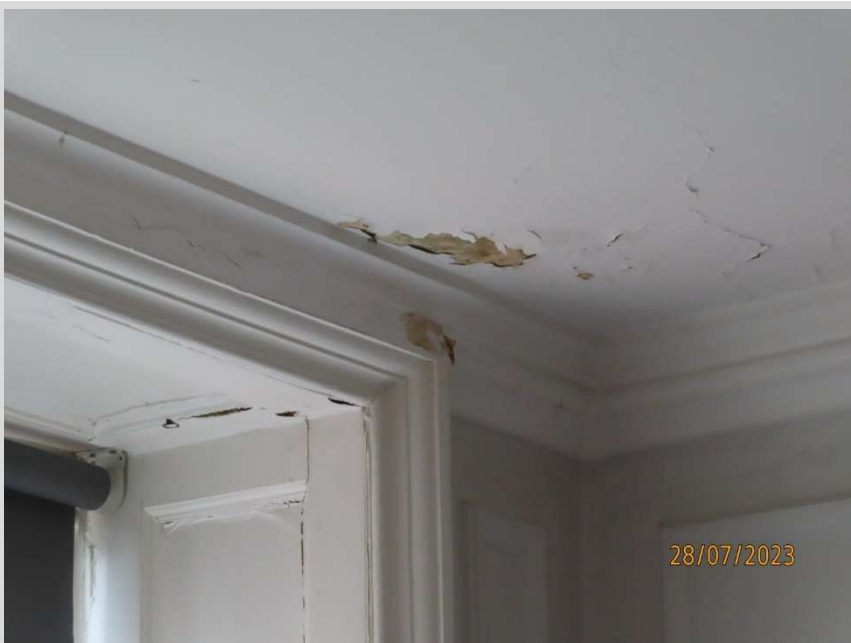
PHOTO 14.2.15b:

Damp ceiling to first floor, rear elevation.

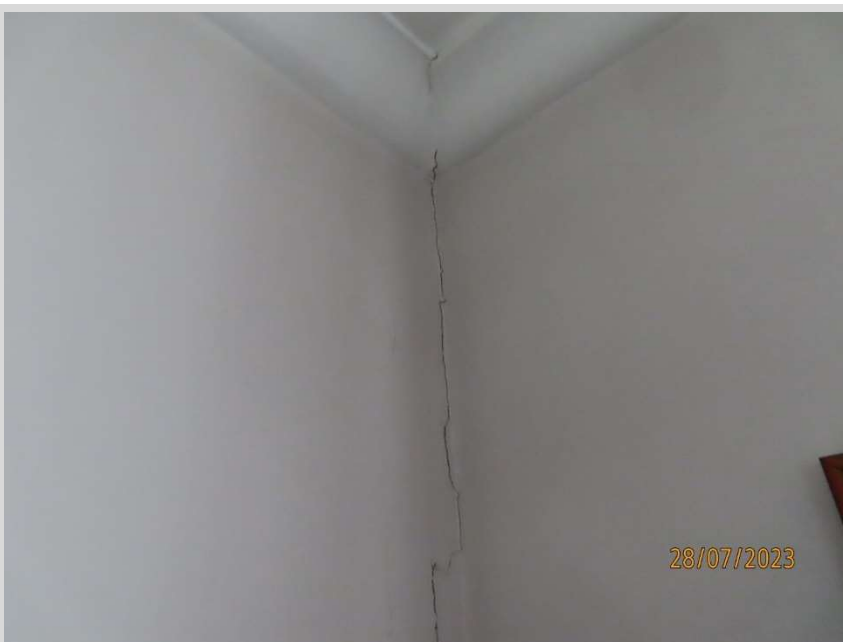
- 14.2.18 The cracking noted in the first floor wall plaster on the north-west side is principally vertically oriented and hairline in nature, located at the junction of the front wall to the dividing partition walls. With reference to BRE Digest 254, the crack widths are relatively minor on the plaster, but they could be wider behind the plaster where the two walls intersect. The walls may not be bonded together and have just naturally separated.

Plaster cracks on first
floor front elevation.

- 14.2.19 Localised plaster removal may help establish the nature and cause of the displacement and help determine whether just cosmetic repairs are required, or more structural intervention is required. There is also some plaster cracking and dampness above the window heads on the front elevation. These cracks seem to coincide with the external cracks around the windows. As described earlier, the cracks are allowing some water penetration which is causing damage, but again, it would be useful to remove some plaster in these areas to establish whether there is any additional disrepair to the brickwork, or any timbers built into the walls.
