Dunstable Town Council
Grove House
76 High Street North
Dunstable
Bedfordshire
LU6 1NF

Date: 19 June 2024

A G E N D A

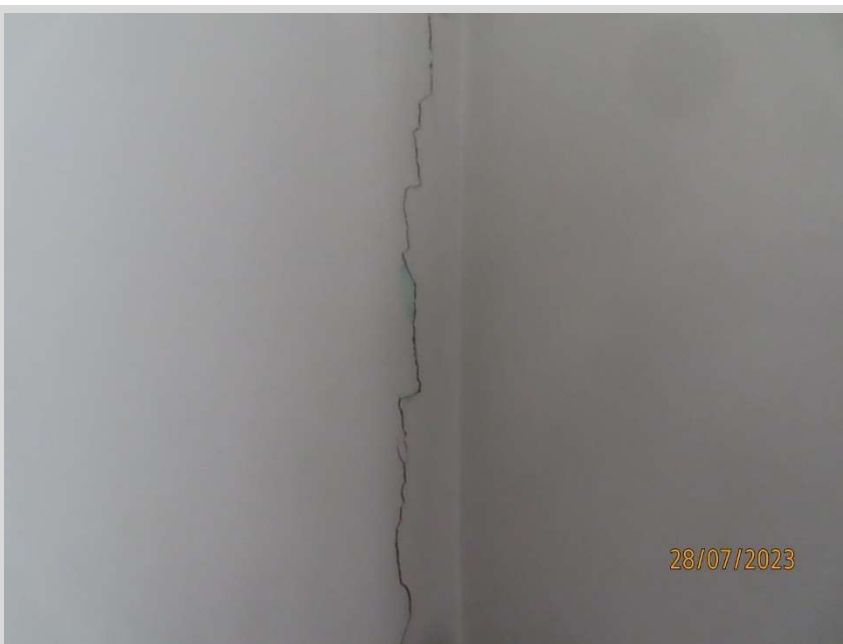
PHOTO 14.2.19b:

- 14.2.18 The cracking noted in the first floor wall plaster on the north-west side is principally vertically oriented and hairline in nature, located at the junction of the front wall to the dividing partition walls. With reference to BRE Digest 254, the crack widths are relatively minor on the plaster, but they could be wider behind the plaster where the two walls intersect. The walls may not be bonded together and have just naturally separated.

Plaster cracks on first
floor front elevation.

- 14.2.19 Localised plaster removal may help establish the nature and cause of the displacement and help determine whether just cosmetic repairs are required, or more structural intervention is required. There is also some plaster cracking and dampness above the window heads on the front elevation. These cracks seem to coincide with the external cracks around the windows. As described earlier, the cracks are allowing some water penetration which is causing damage, but again, it would be useful to remove some plaster in these areas to establish whether there is any additional disrepair to the brickwork, or any timbers built into the walls.

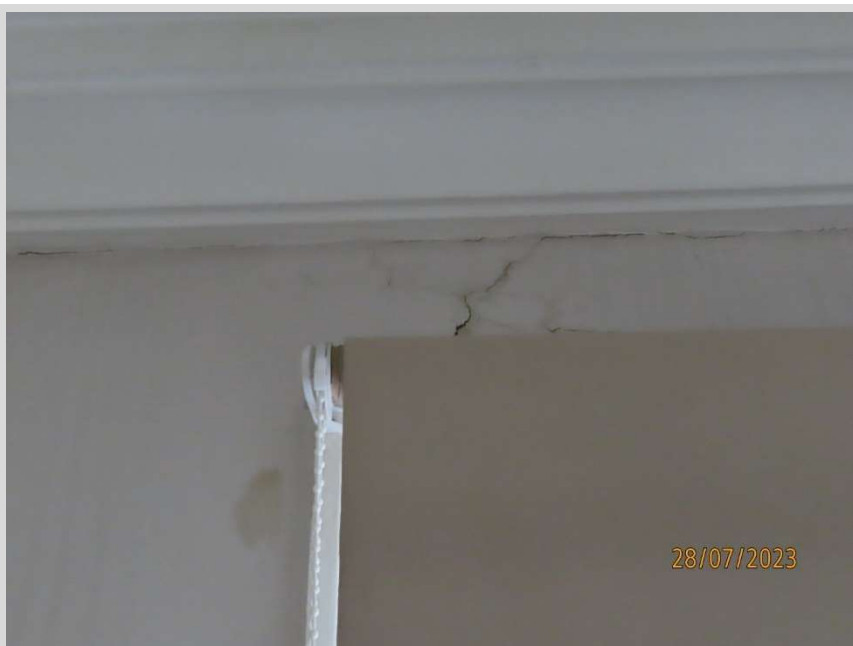
PHOTO 14.2.19c:

Plaster crack and dampness above first floor window lintel.

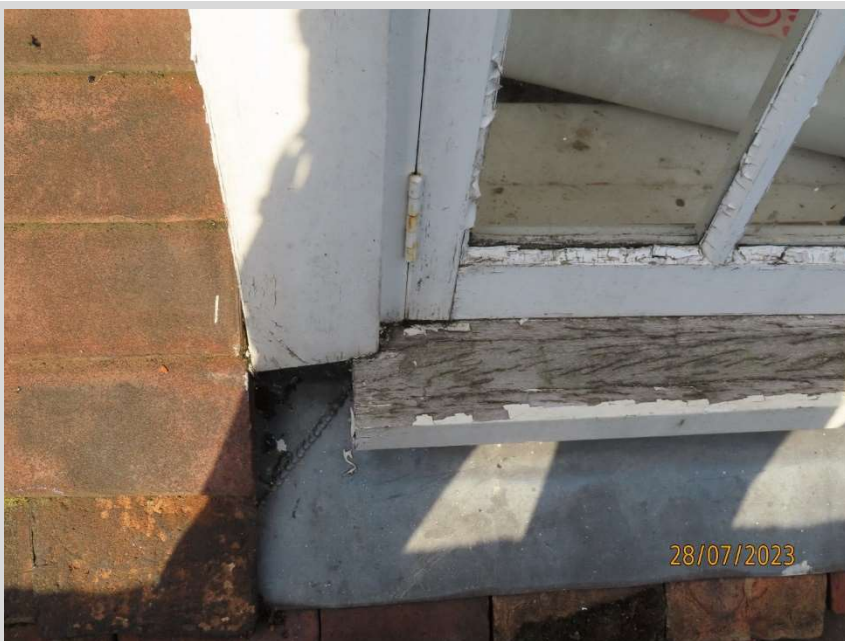
PHOTO 15.2.1a:

- 15.2.1 Most of the windows require overhaul and repair; there are a significant number of windows, and in many areas, the timber has become decayed and open grained. Some of the window cills and frames are severely decayed and will need renewal.

Decayed window cill on
attic roof window.

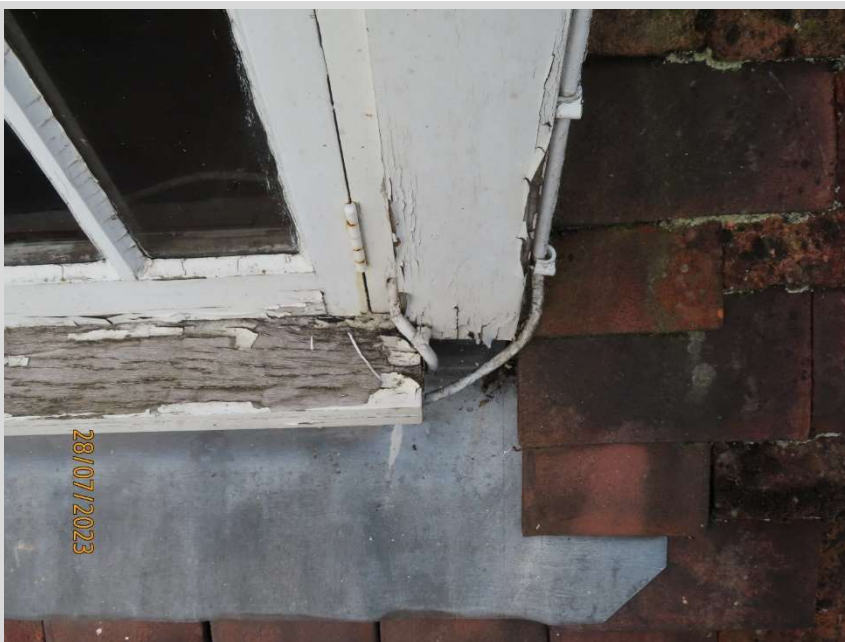
PHOTO 15.2.1b:

Decayed window cill on
attic roof window.

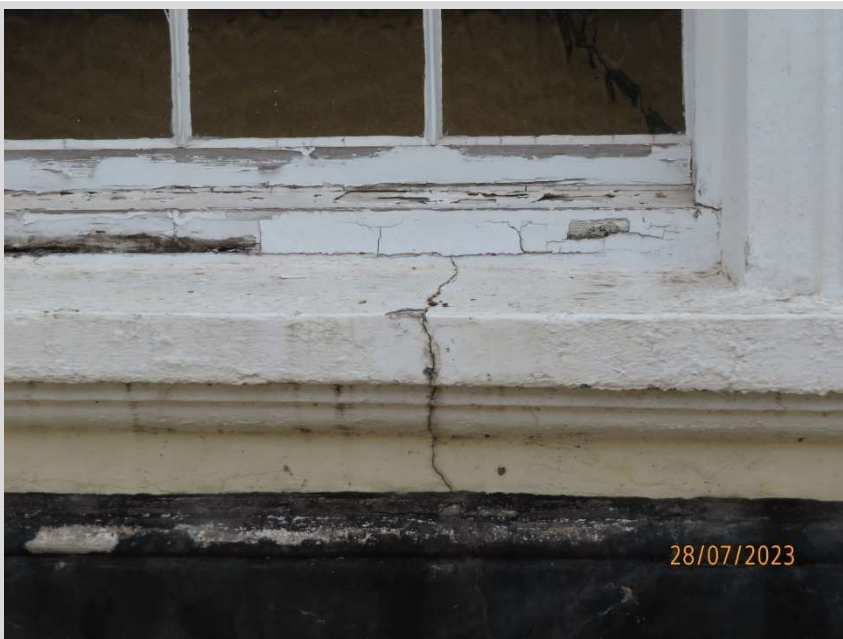
PHOTO 15.2.1c:

Typical decay on front elevation window.

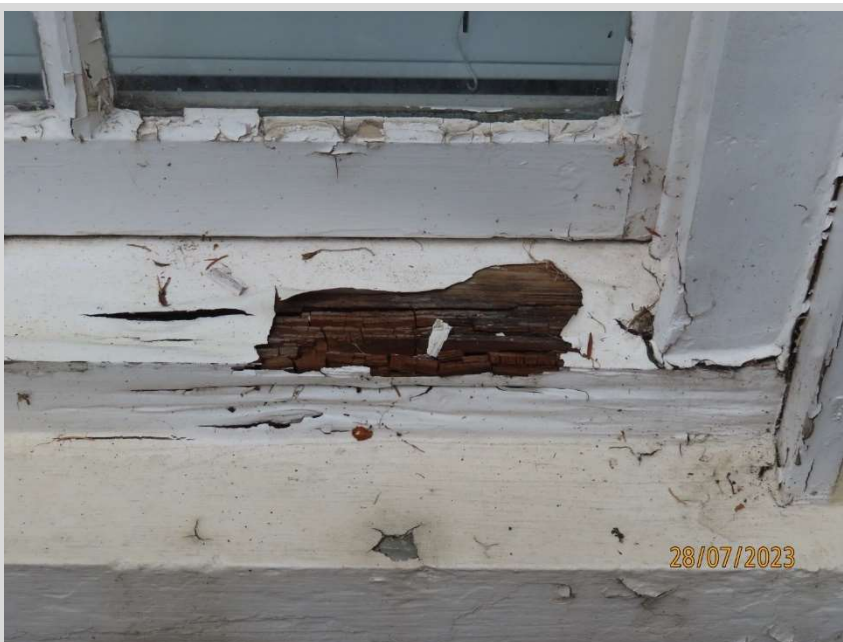
PHOTO 15.2.1d:

Decay on rear elevation window.

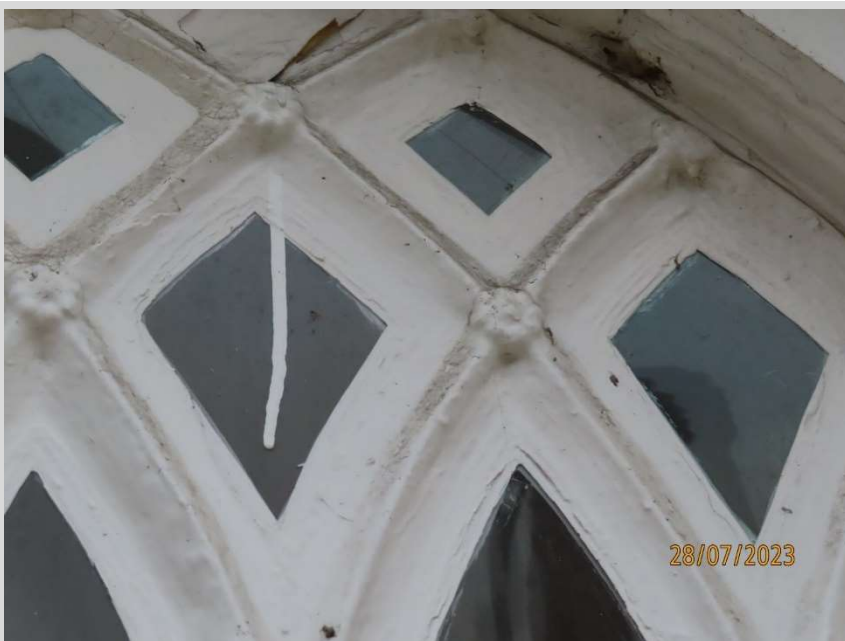
PHOTO 15.2.2:

- 15.2.2 Following repairs to the timber windows, redecoration will be necessary, but the standard of decorative works should be improved. In many areas the detailing of the window frames has been lost due to overpainting on the glass which detracts from the attractiveness of the window framing.

Overpainting on glazing
of window sections.

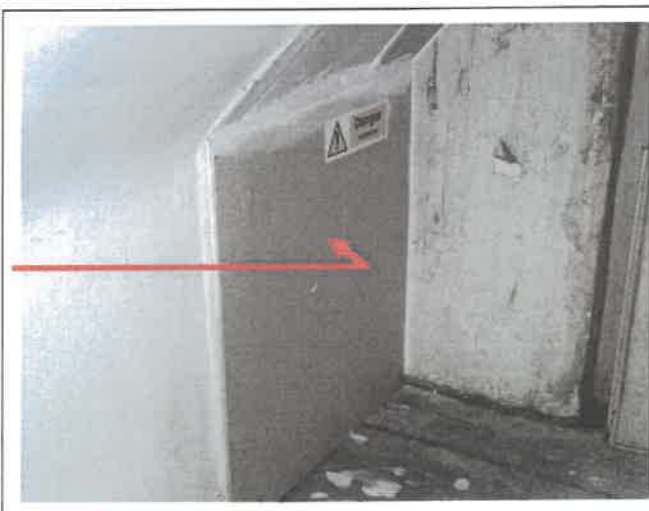
Photo 3

Second floor corridor: Void with pipe
lagging in.

Contains Amosite & Chrysotile
asbestos.

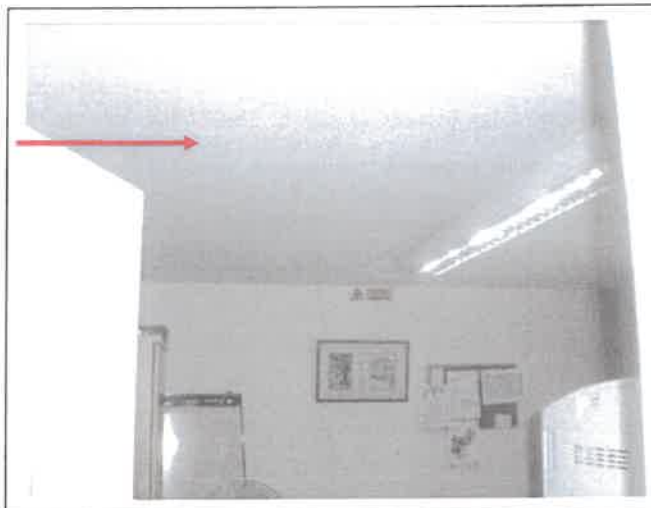
Photo 4

Ceiling of Office 1 on the First floor.

Contains Chrysotile asbestos.
